# VERIFICATION REQUIREMENTS FOR GAS PROTECTION SYSTEMS

Technical Guidance for  
Developers,  
Landowners and  
Consultants

Yorkshire and Humberside  
Pollution Advisory Council

Version 1.0 – January 2016

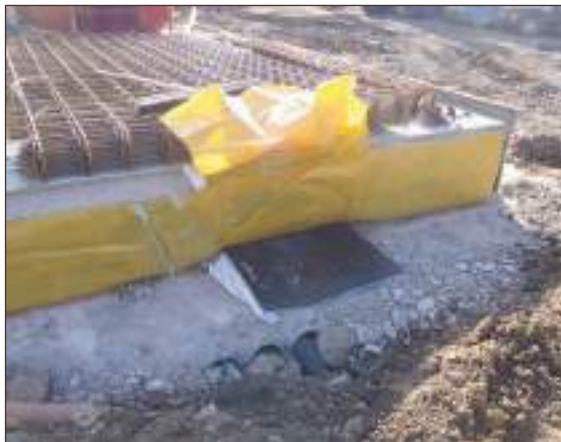
**Figure A4.7** *Geovent protruding out of the frontage of the unit. Gas membrane along the sides of the slab preventing lateral gas ingress (courtesy Alderburgh Group)*

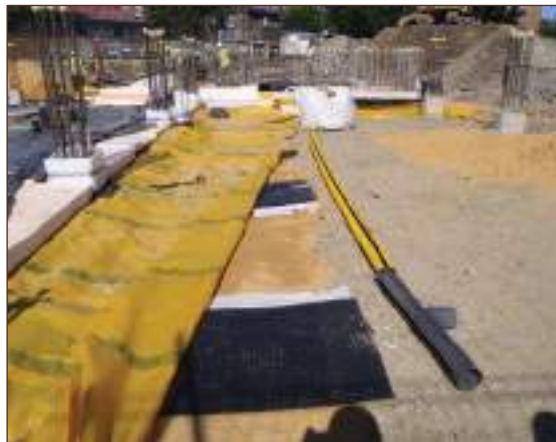
**Figure A4.8** *Geovent beneath the 2000g taped gas membrane lined up with collector pipes (courtesy Alderburgh Group)*

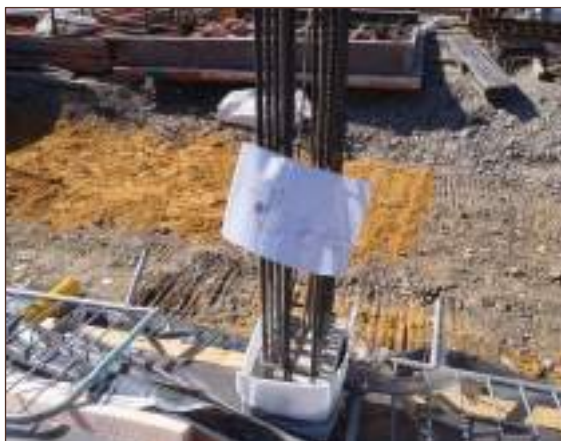
**Figure A4.9** *On site schematics to aid construction workers build the gas protection system (courtesy Alderburgh Group)*

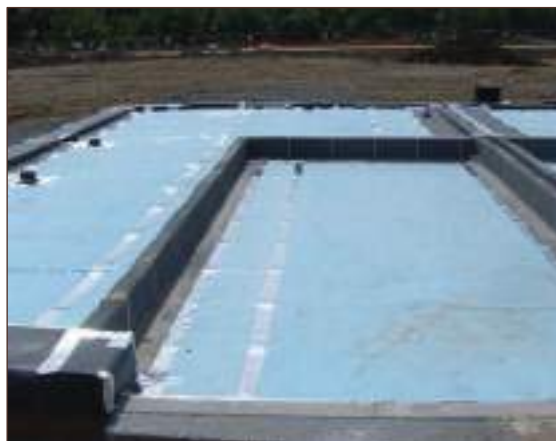
**Figure A4.10** *Almost complete coverage available for inspection, minimal jointing, service entries suitable distance from walls, light traffic (courtesy Smith Grant)*

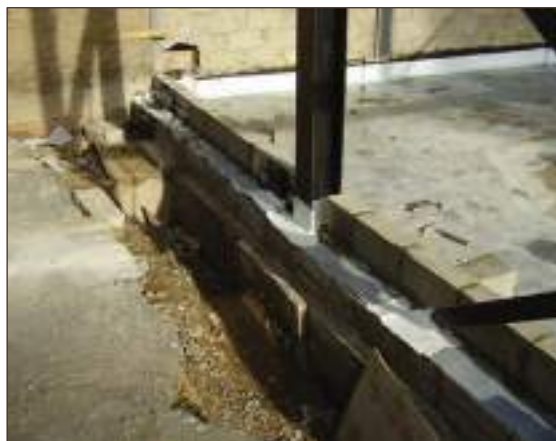
**Figure A4.12** *Good edge detail across cavity (courtesy PAGEotechnical Ltd)*

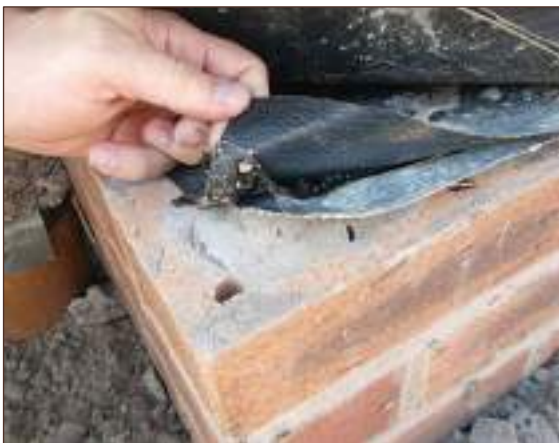
**Figure A4.13** Gas proof DPC adhered on top of gas membrane using butyl strips across cavity space (courtesy NHBC)

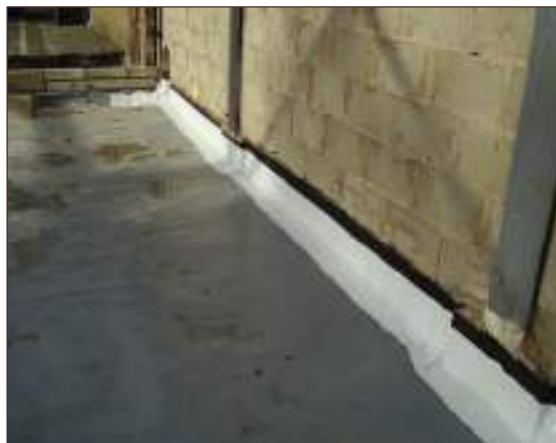
**Figure A4.14** Good perimeter seal (courtesy PAGEotechnical Ltd)

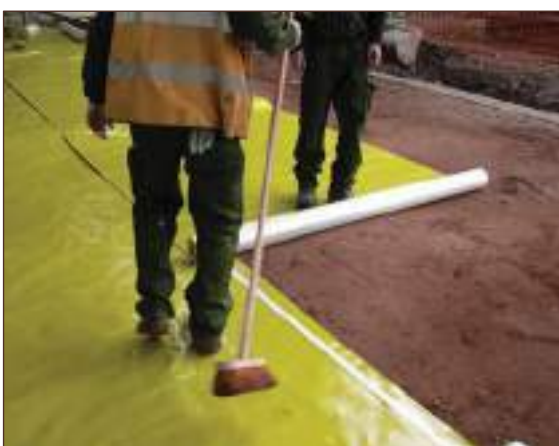
**Figure A4.15** LDPE type gas membrane overlap and double sided tape. Sand blinding to protect underside of gas membrane (courtesy A Proctor Group)

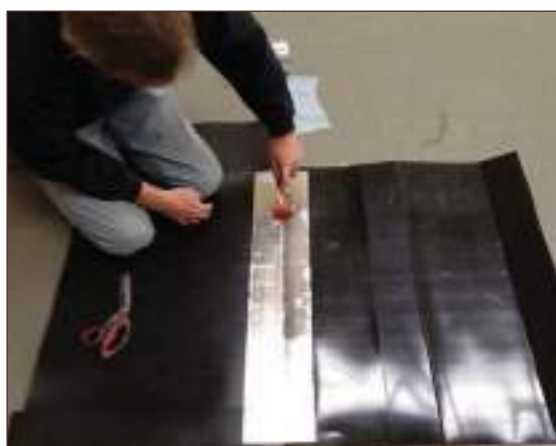
**Figure A4.16** Example HDPE type gas membrane and steam roller used to ensure self-adhesive tape is correctly installed (courtesy A Proctor Group)

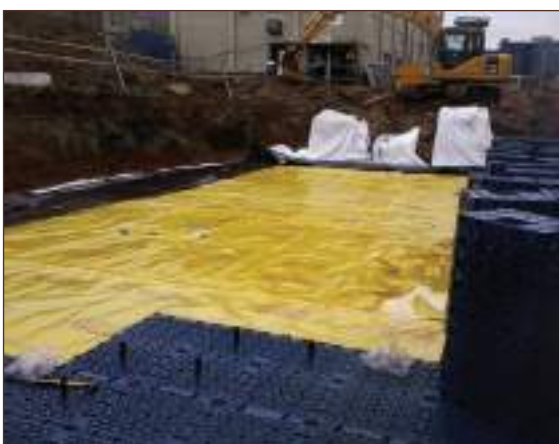
**Figure A4.17** Gas membrane installed in attenuation tank (courtesy Industrial Textiles & Plastics Ltd)

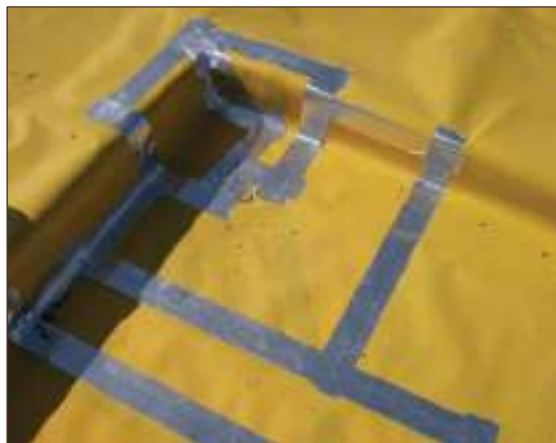
**Figure A4.20** A pre-formed corner unit would have been preferable as fewer joints would have been formed, however the installer has achieved a good level of workmanship in this corner detail (courtesy Smith Grant)

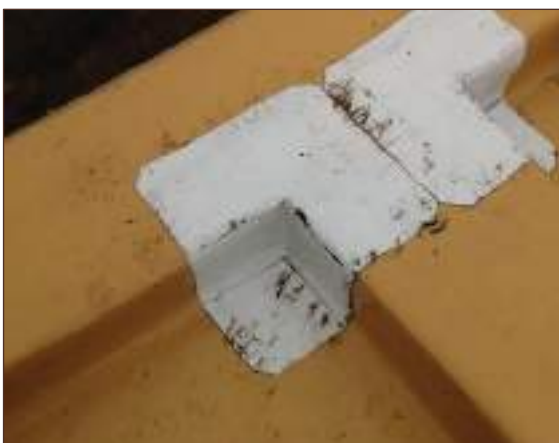
**Figure A4.21** Good prefabricated corner detail (courtesy MEC Environmental Ltd)

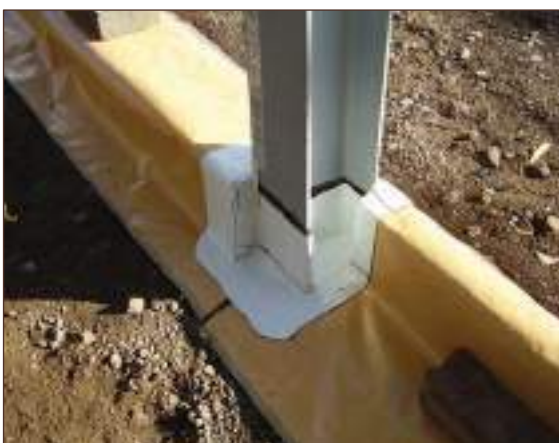
**Figure A4.23** Complex column seal (courtesy PAGEotechnical Ltd)

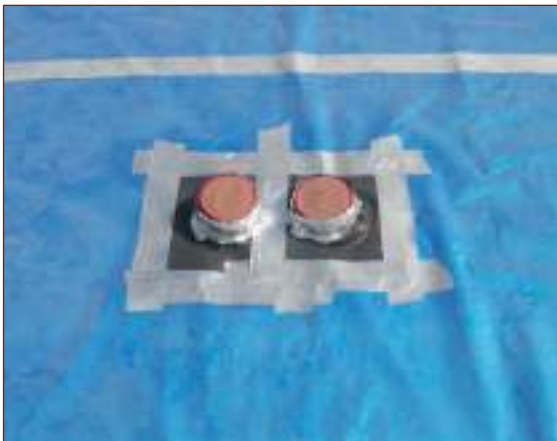
**Figure A4.27** Top hats placed around service entries secured with jubilee clip seals. Top hats secured to gas membrane with double sided butyl tape (courtesy Hydrock)

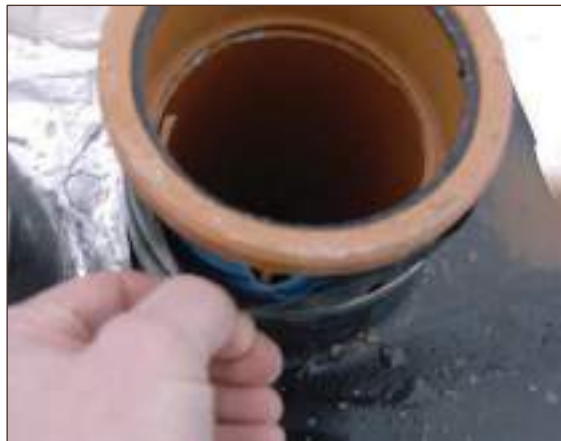
**Figure A4.28** Bead of double sided butyl tape provided between interfaces of ID top hat and OD service pipe. When compressed with jubilee clip, forms an effective seal (courtesy Smith Grant)

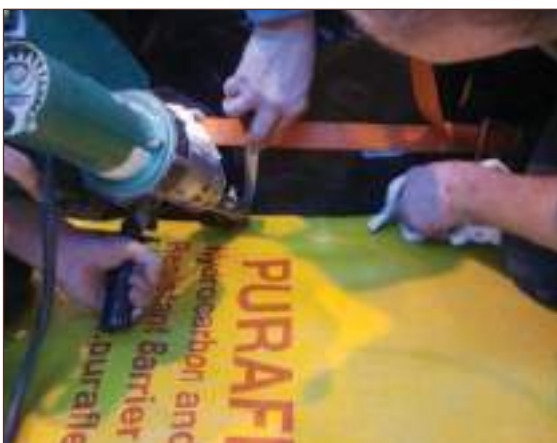
**Figure A4.29** Extrusion welding technique (courtesy Industrial Textiles & Plastics Ltd)

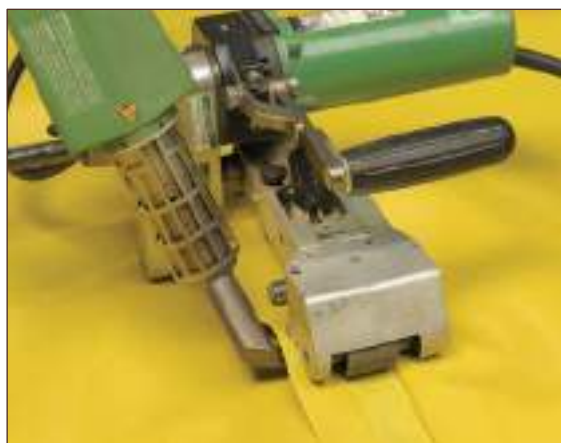
**Figure A4.30** Thermal welding technique (courtesy Industrial Textiles & Plastics Ltd)

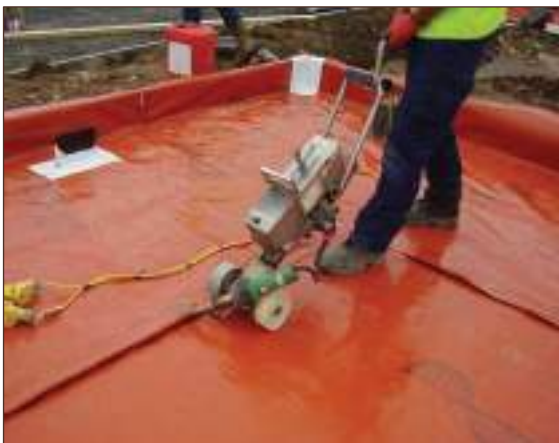
**Figure A4.31** Extrusion welding (courtesy PAGeotechnical Ltd)

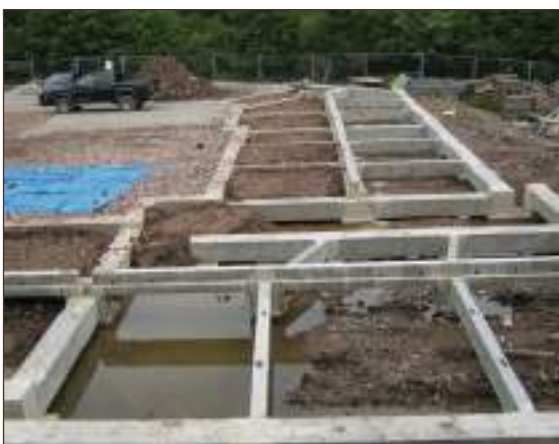
**Figure A4.33** Good ventilation in internal sleeper walls, cast into prefabricated beams (courtesy Smith Grant)

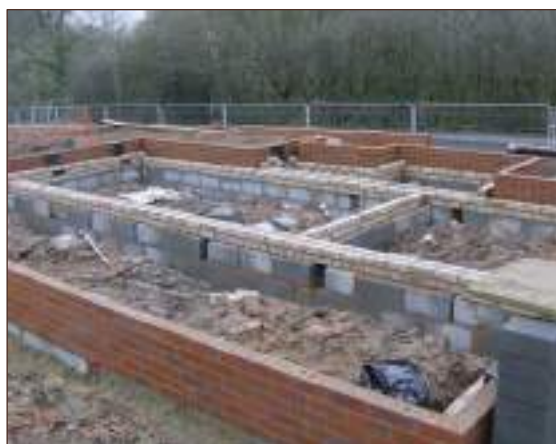
**Figure A4.34** Open void >300mm deep, good ventilation through internal sleeper walls (courtesy Smith Grant)

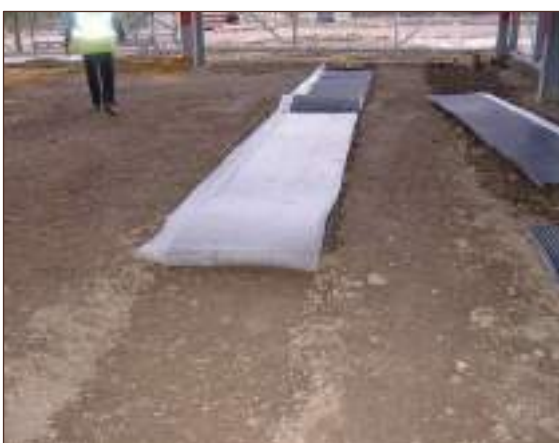
**Figure A4.35** Good installation of passive gas venting trenches and 'egg-crate' (courtesy Card Geotechnics Limited)

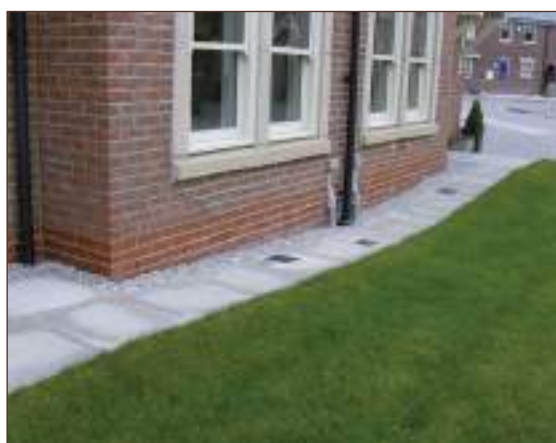
**Figure A4.36** Raised air bricks are preferable due to the reduced potential for blockade but the vent trench specified is provided with clean single sized stone (courtesy Smith Grant)

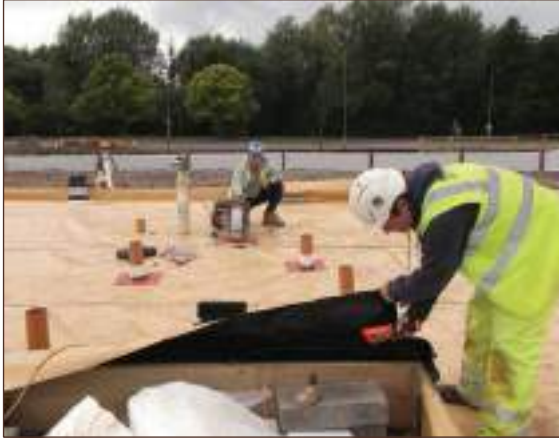
**Figure A4.37** Tracer gas testing, whereby gas or smoke is applied under pressure beneath the installed gas membrane and detectors are used to screen for leaks above (courtesy NHBC)

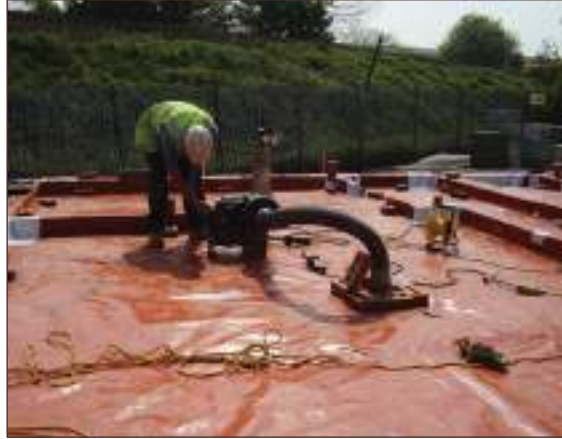
**Figure A4.38** Tracer gas testing (courtesy PAGEotechnical Ltd)

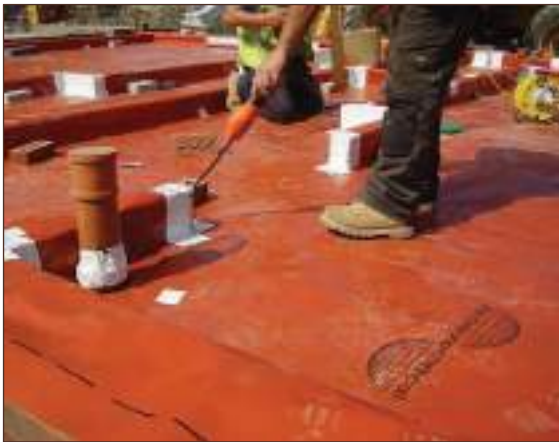
**Figure A4.39** Scanning for leaks (courtesy PAGEotechnical Ltd)

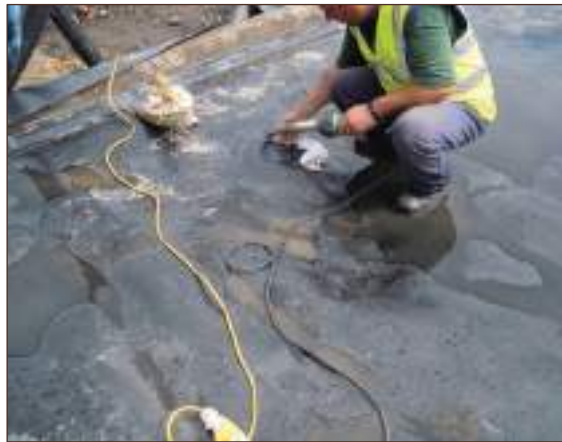
**Figure A4.40** CO<sub>2</sub> injection integrity testing (courtesy Landline Ltd)

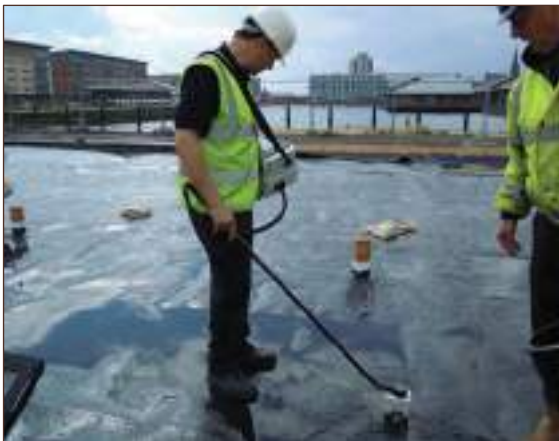
**Figure A4.41** Small sand bags are marking holes made in the gas membrane used to check whether injected CO<sub>2</sub> has worked its way beneath whole area (courtesy Landline Ltd)

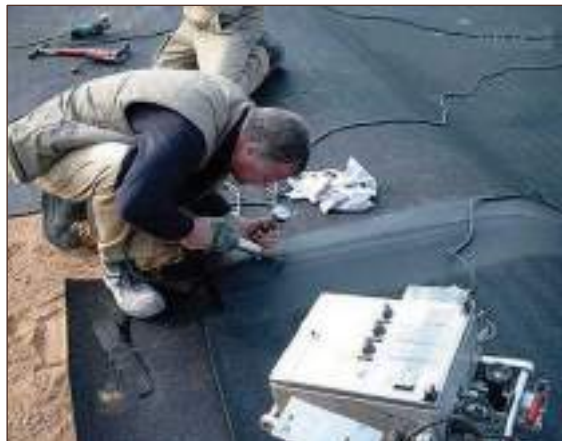
**Figure A4.42** Air pressure testing (courtesy GSE Environmental)

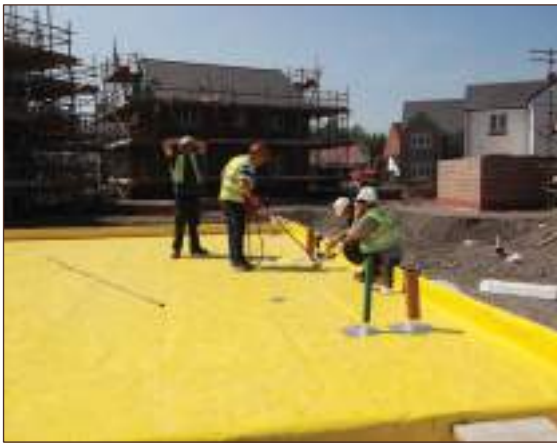
**Figure A4.43** Dielectric porosity testing for housing scheme (courtesy NHBC)

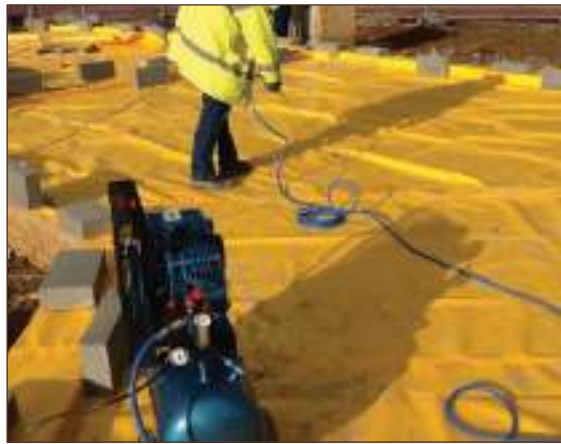
**Figure A4.44** Air lance test, used to test the quality of welded seams along gas membrane joints (courtesy MEC Environmental Ltd)

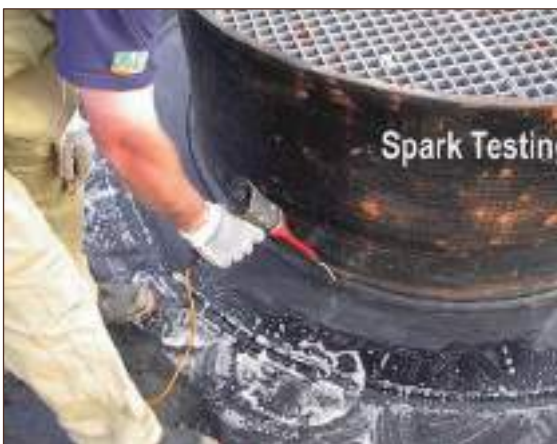
**Figure A4.45** Spark testing (courtesy GSE Environmental)

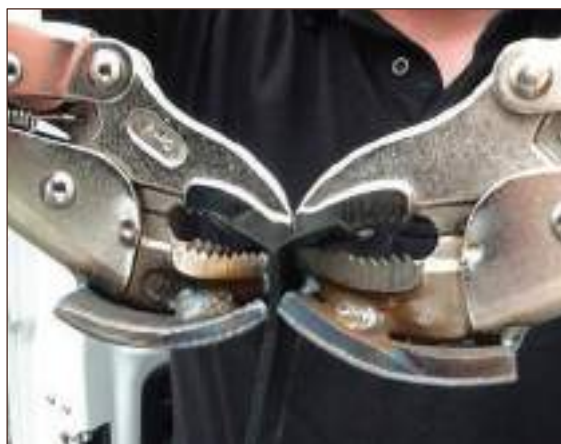
**Figure A4.46** Testing a weld with 'dog bone' grips (courtesy MEC Environmental Ltd)

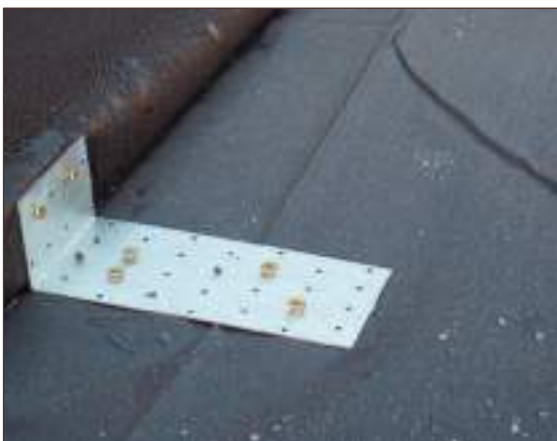
**Figure A4.47** Follow-on works purposefully penetrating gas membrane (courtesy Card Geotechnics Limited)

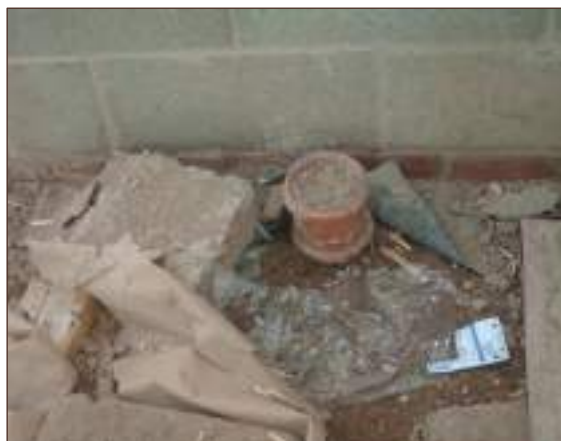
**Figure A4.48** Loose nails and over construction debris likely to be left in place beneath gas membrane – poor preparation of gas membrane prior to sealing service penetration (courtesy Card Geotechnics Limited)

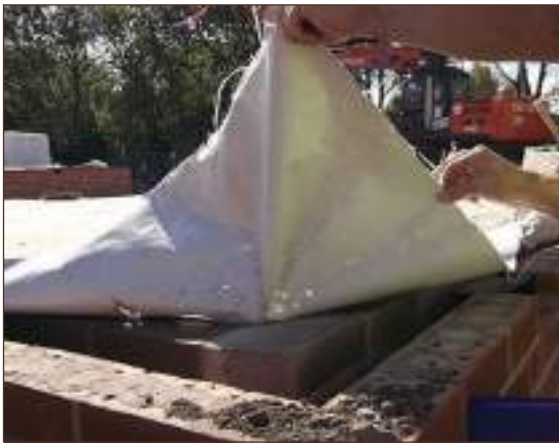
**Figure A4.49** *Lifted gas membrane at corner position. Light penetrating through confirms damage to aluminium internal core layer (courtesy NHBC)*

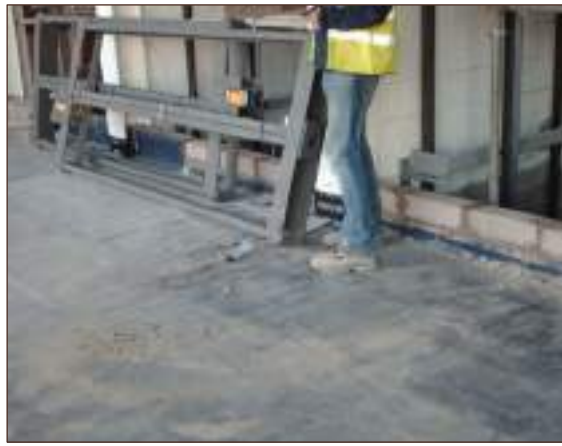
**Figure A4.50** *Large/heavy/sharp objects being moved over unprotected gas membrane (courtesy Card Geotechnics Limited)*

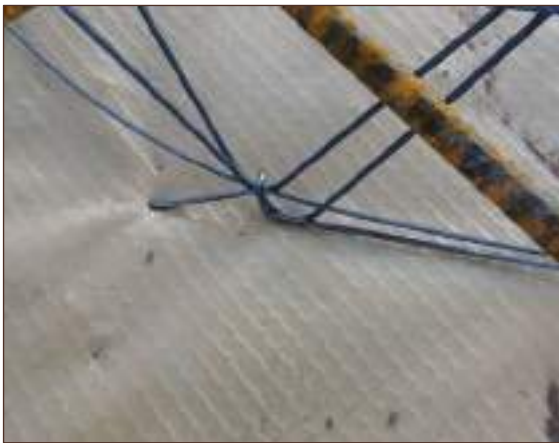
**Figure A4.51** *Gas membrane torn by reinforcement (courtesy MEC Environmental Ltd)*

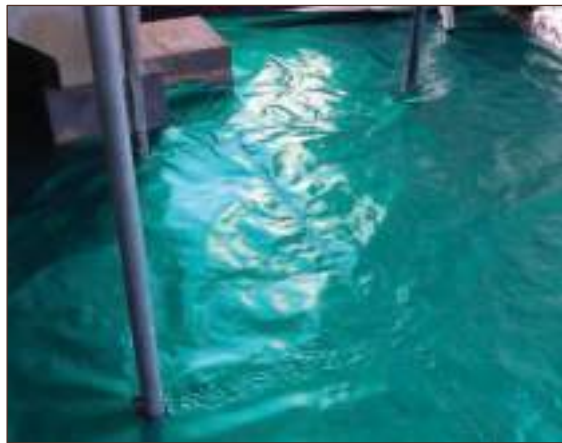
**Figure A4.52** *Gas membrane cut by scaffolders and bricklayers after installation (courtesy MEC Environmental Ltd)*

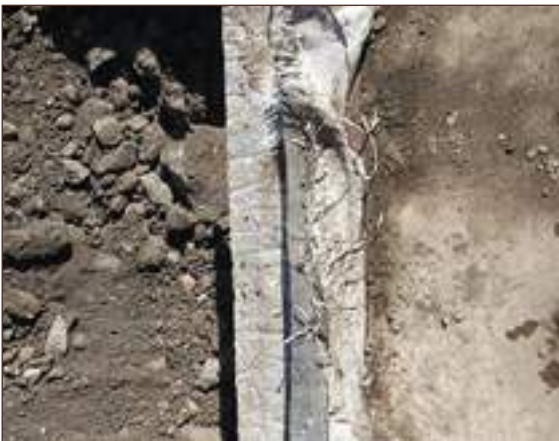
**Figure A4.53** *Gas membrane left exposed for long period of time, shows significant fraying at cavity edge (courtesy NHBC)*

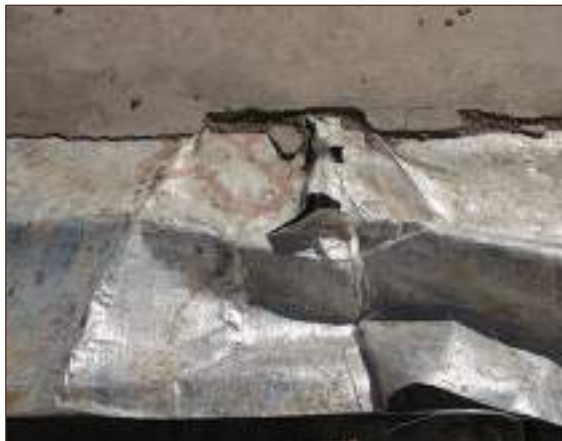
**Figure A4.54** *Gas membrane damage/tearing at edge of ground floor slab screed layer where it was left exposed to elements for period of time (courtesy NHBC)*

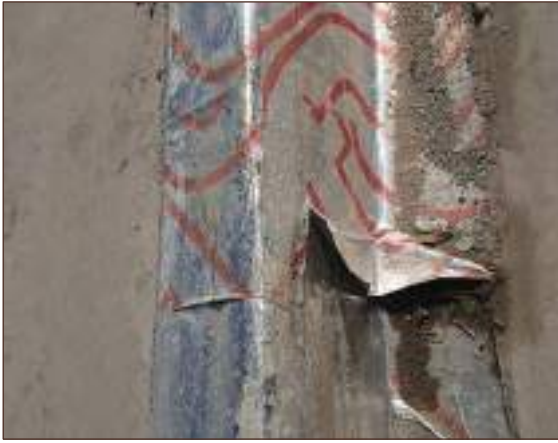
**Figure A4.55** Gas membrane at stepped junction of slab to integral garage, appears to be susceptible to tearing when screed is poured. Screed may also weigh down on gas membrane if fitted too tight (courtesy NHBC)

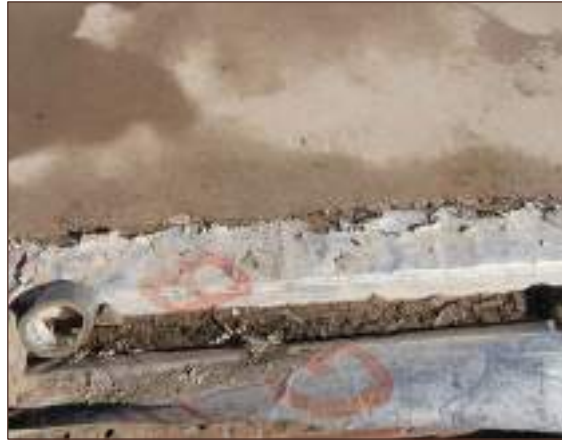
**Figure A4.56** Gas membrane at edge of concrete screed. Screed has been grinded to achieve desired levels, gas membrane shows extreme wear and damage as a result (courtesy NHBC)

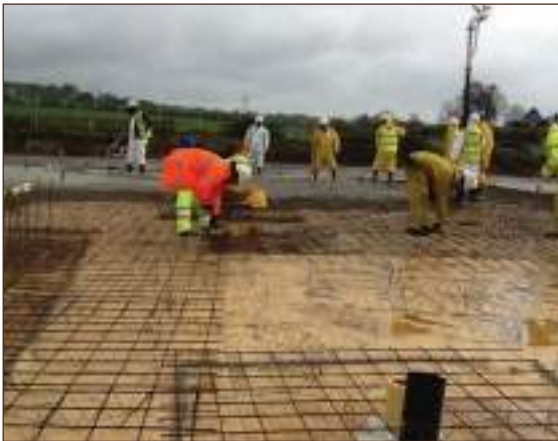
**Figure A4.57** Unprotected gas membrane damaged by heavy traffic (courtesy MEC Environmental Ltd)

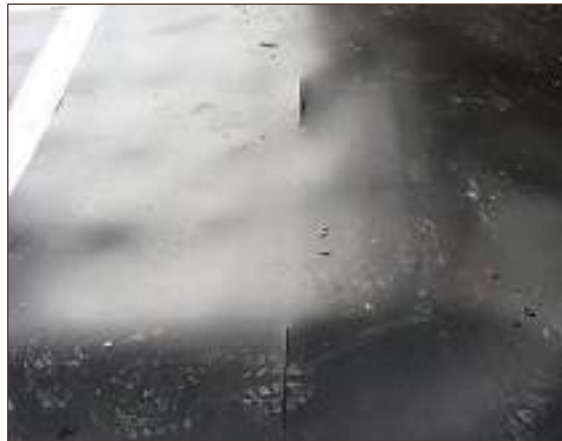
**Figure A4.58** Damage caused to gas membrane by follow-on trade who cut/shaped the dry lining board directly on the unprotected installed gas membrane (courtesy NHBC)

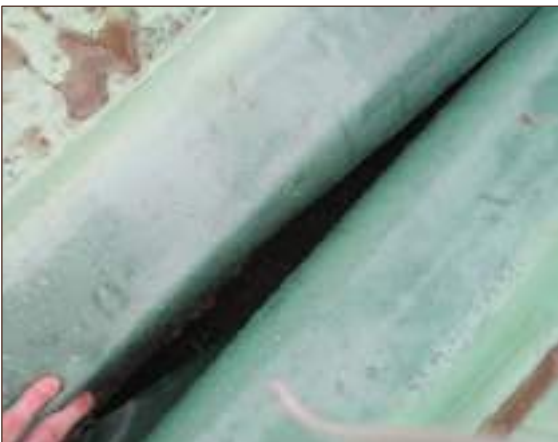
**Figure A4.59** Gas membrane slit at the bottom of a cavity tray to enable water to drain away (courtesy Smith Grant)

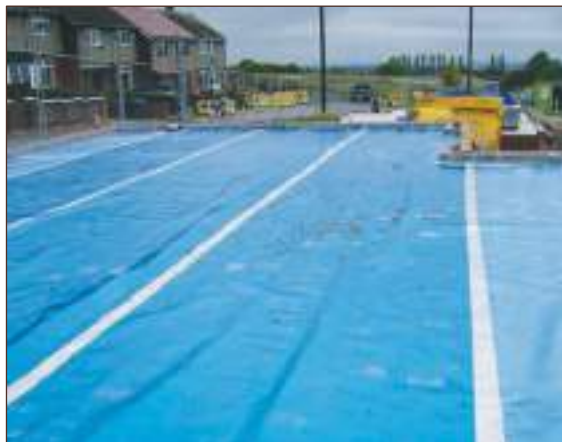
**Figure A4.60** Some stones could penetrate gas membrane if sufficient force is applied (courtesy Smith Grant)

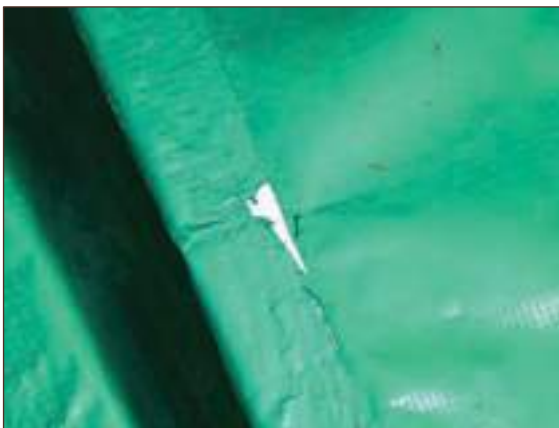
**Figure A4.61** *'Stripping' occurs on gas membranes that contain aluminium foil. The foil gets too hot under the outer layer of LDPE or PP and the top layer of the gas membrane sticks to the roller which strips it off, leaving the aluminium completely exposed (courtesy MEC Environmental Ltd)*

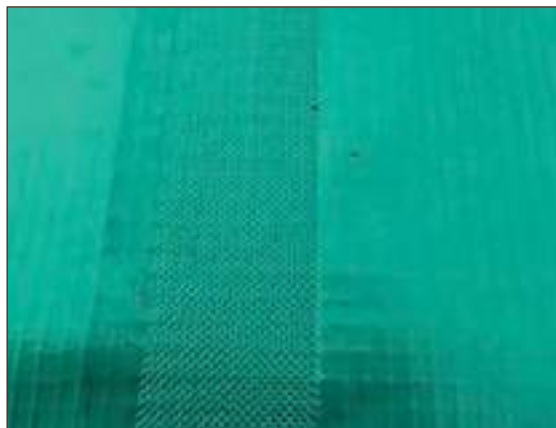
**Figure A4.62** *Wedge weld on an LDPE aluminium gas membrane, where the installer used metal nip rollers. This destroyed the top layer and probably the bottom layer, leaving aluminium exposed between the weaves. This failed dielectric testing along all joints (courtesy MEC Environmental Ltd)*

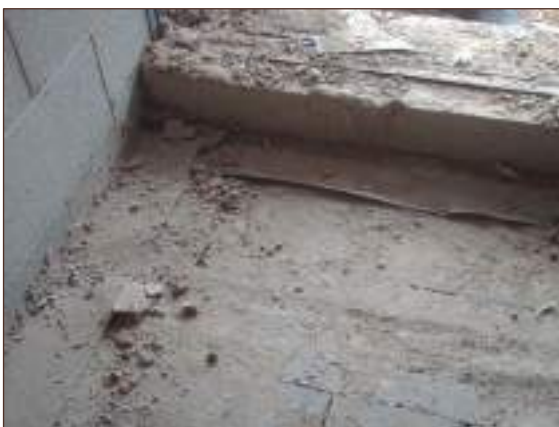
**Figure A4.63** *Absence of surface preparation prior to laying of gas membrane, debris likely to pierce gas membrane (courtesy Card Geotechnics Limited)*

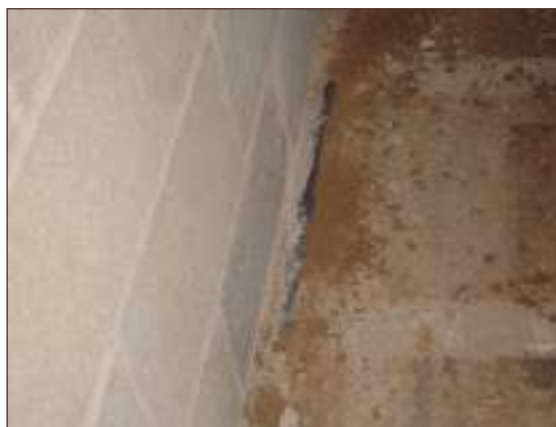
**Figure A4.64** *Insufficient length of gas membrane protruding through wall to overlap with gas membrane within building (courtesy Card Geotechnics Limited)*

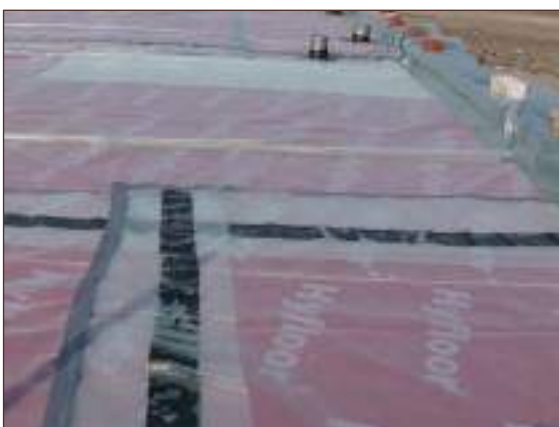
**Figure A4.65** *Wrinkling of gas membrane over joint has resulted in gaps (only visible due to the use of a transparent gas membrane) and the secondary seal uses ordinary gaffer tape rather than a proprietary product (courtesy Smith Grant)*

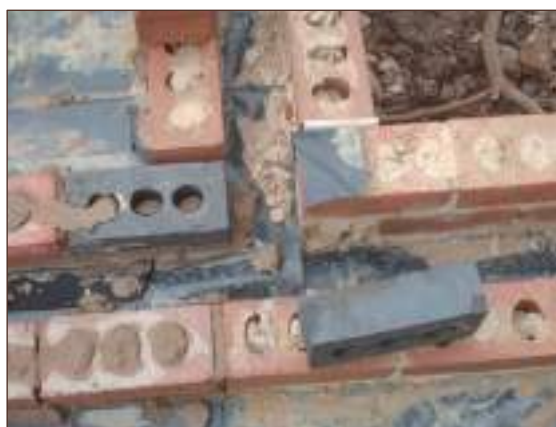
**Figure A4.66** *Follow-on trades proceeded work before gas membrane joints sealed (courtesy Card Geotechnics Limited)*

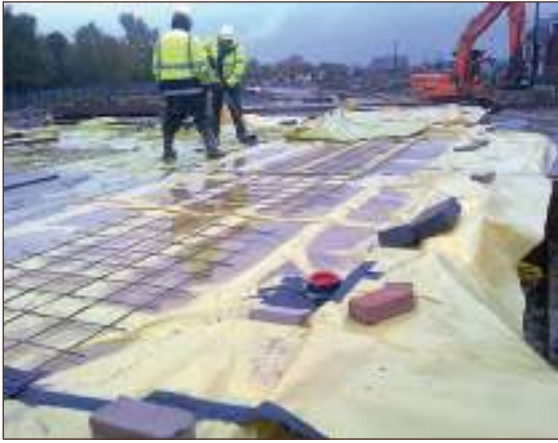
**Figure A4.67** Traffic over mesh resulted in several punctures, in addition most joints were found to be poorly constructed. Taped joints are difficult to construct in adverse weather (courtesy Smith Grant)

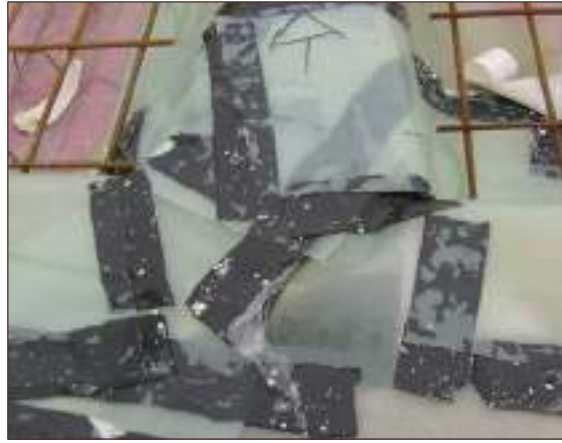
**Figure A4.68** A pre-formed corner unit would have been preferable. The installer could not produce sufficient quality despite the amount of tape applied (courtesy Smith Grant)

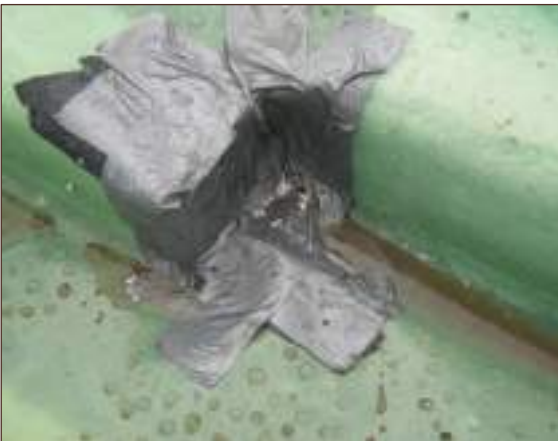
**Figure A4.69** Attempt at corner detailing using non-proprietary duct tape (courtesy Smith Grant)

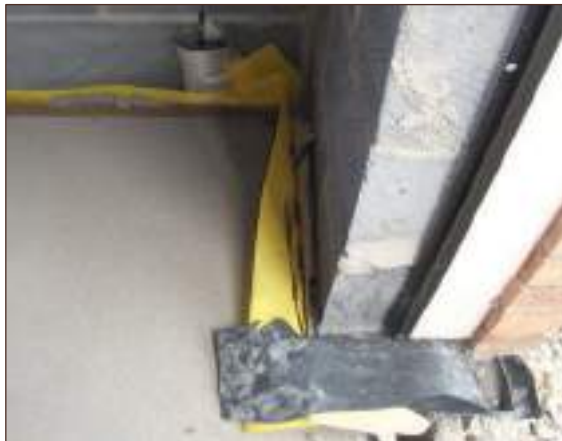
**Figure A4.70** Inadequate corner detailing. The use of preformed proprietary products would have avoided such bad practice (courtesy NHBC)

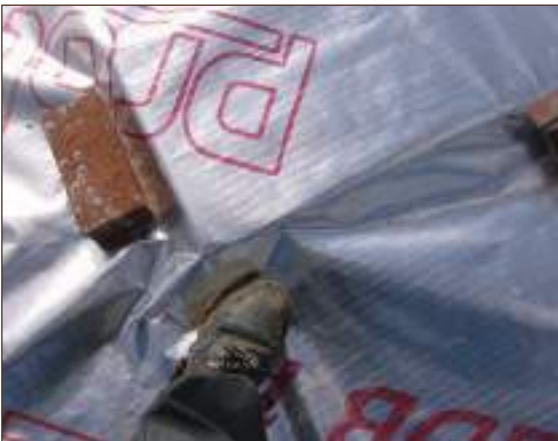
**Figure A4.71** No corner detailing leading to stress point on gas membrane (courtesy Smith Grant)

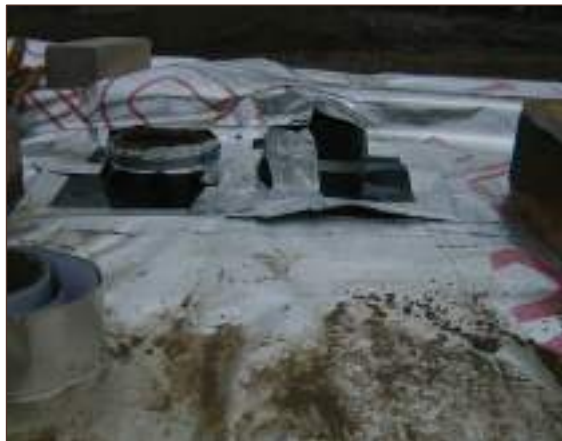
**Figure A4.72** Joint between top hat and gas membrane has lifted due to poor fit and attempt to construct in very wet conditions (courtesy Smith Grant)

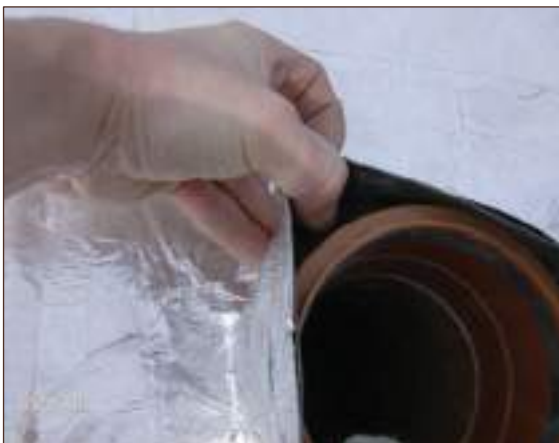
**Figure A4.73** No bead of double sided butyl tape provided between interfaces of ID top hat and OD service pipe: cannot be compressed enough to form seal (courtesy Smith Grant)

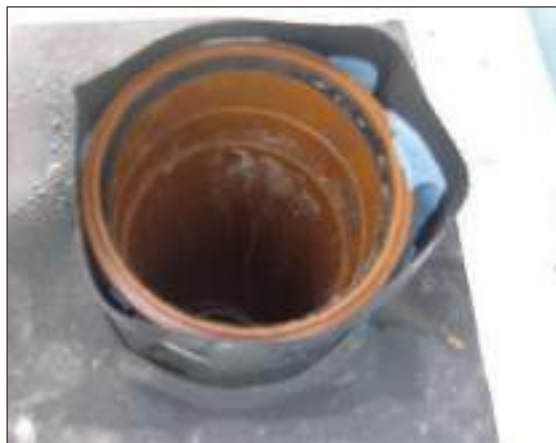
**Figure A4.74** Gap between OD of service pipe and ID of top hat too large: cannot be compressed enough to form seal, even with the application of additional tape (courtesy Smith Grant)

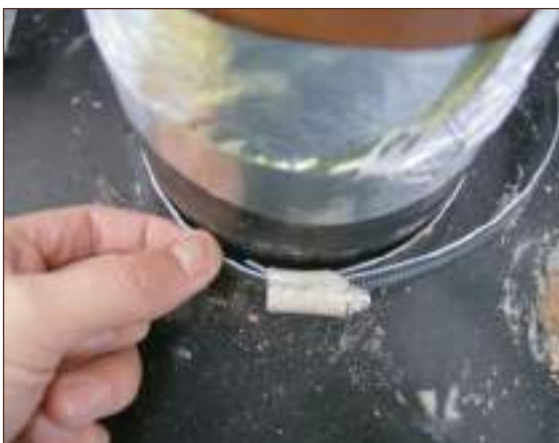
**Figure A4.75** Jubilee clip on service entry insufficiently tightened so joint is uncompressed (courtesy Smith Grant)

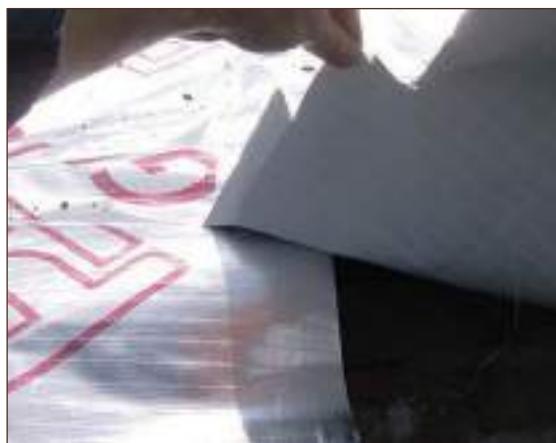
**Figure A4.76** No double sided tape used in joints (courtesy Smith Grant)

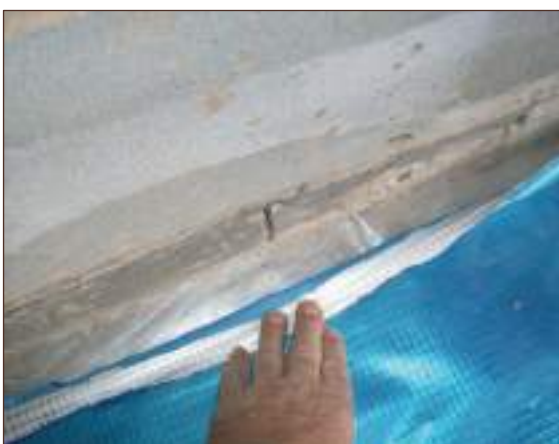
**Figure A4.77** Small lap and no single sided tape used to achieve secondary seal (courtesy Smith Grant)

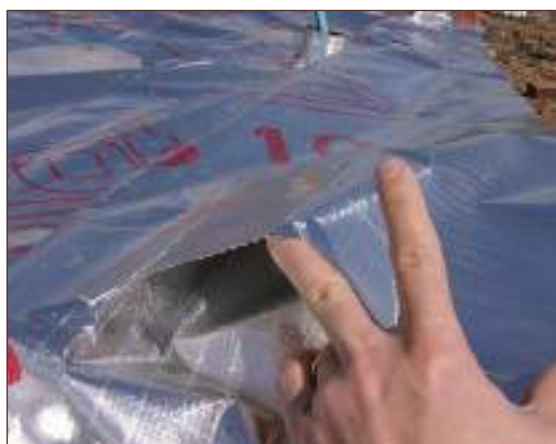
**Figure A4.78** Gap in jointing over wall cavity big enough to insert fist (courtesy Smith Grant)

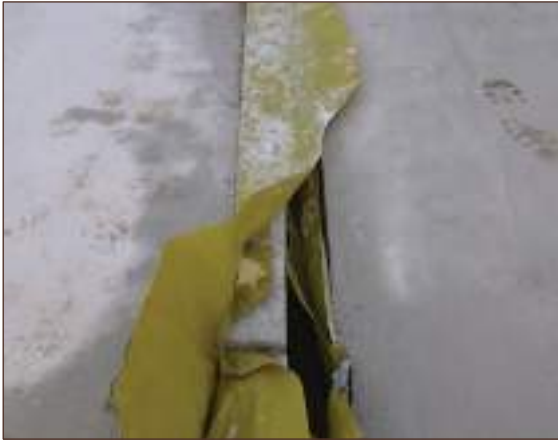
**Figure A4.79** Gas membrane not continuous over internal wall. It had been deliberately cut open for unknown purpose (courtesy Smith Grant)

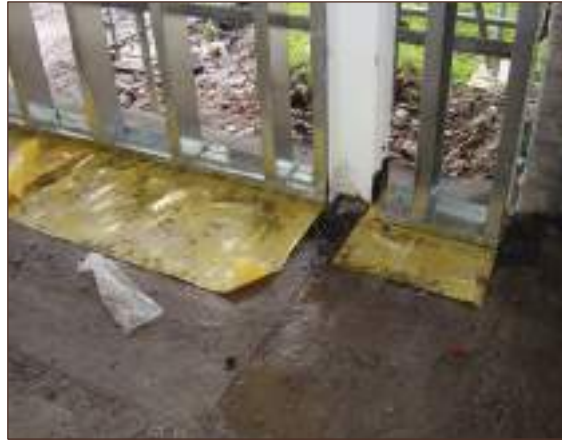
**Figure A4.80** Column left unsealed (courtesy PAGEotechnical Ltd)

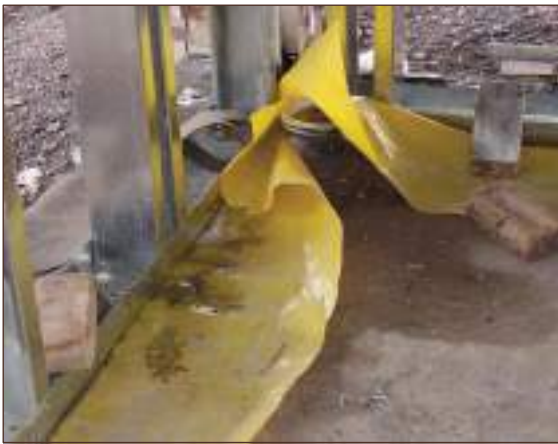
**Figure A4.81** No seal to perimeter pipe (courtesy PAGEotechnical Ltd)

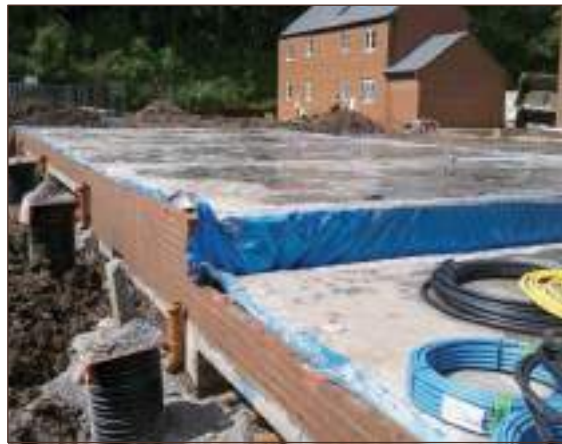
**Figure A4.82** Gas membrane used to bridge cavity wall instead of DPC, leaving it exposed to damage by follow-on trades (courtesy Smith Grant)

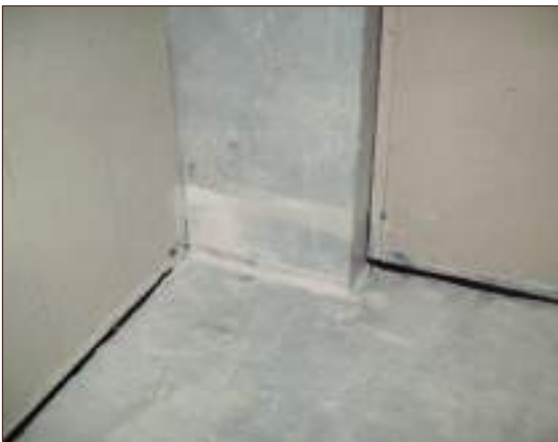
**Figure A4.83** Poor quality installation of liquid gas membrane. Liquid gas membranes come in two colours (black and white) allowing coverage of each coat to be easily assessed. Here the gas membrane has been spread too thinly and inconsistently. In addition, it appears to have been applied to a damp surface, causing blistering (courtesy Card Geotechnics Limited)

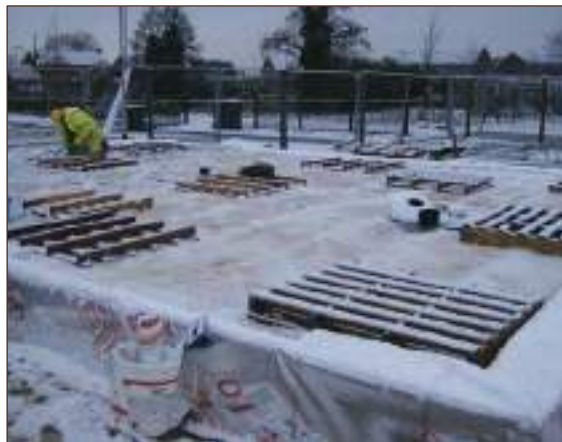
**Figure A4.84** Taped joints are difficult to construct in adverse weather. Also difficult to inspect if covered with snow (courtesy Smith Grant)

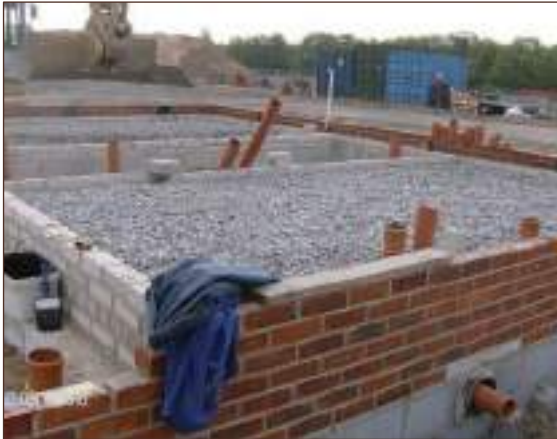
**Figure A4.85** Clean single sized stones with no fines acting as venting media, however no ventilation gaps in internal sleeper walls (courtesy Smith Grant)

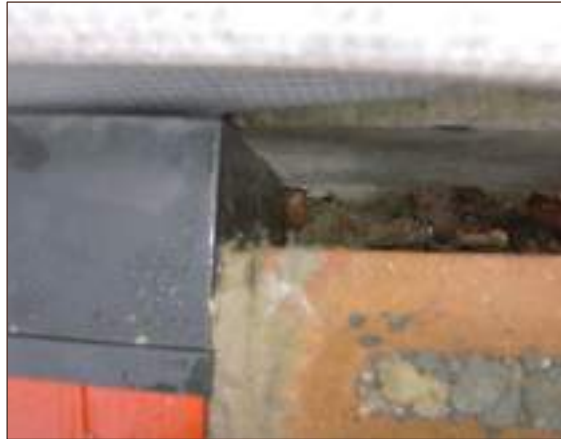
**Figure A4.86** Cavity is becoming blocked with detritus. The vent holes in the beam are no longer visible (courtesy Smith Grant)

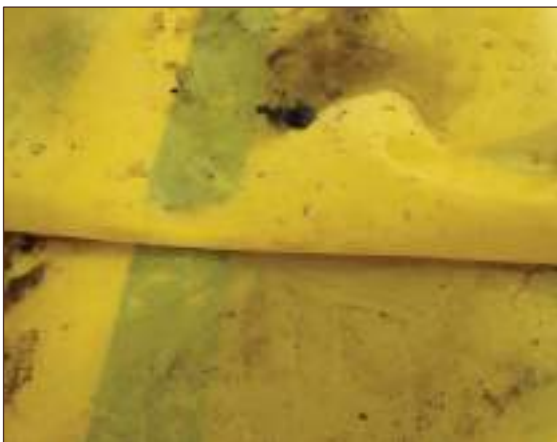
**Figure A4.87** Tape joint with crease running through and air bubbles where gas membrane not in complete contact with tape. Rollers should have been used to produce a consistent seal (courtesy MEC Environmental Ltd)

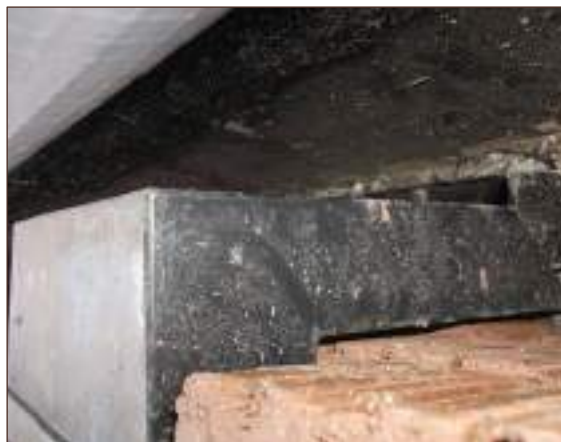
**Figure A4.88** Ventilator becoming detached to fit to external block work. This is due to builders requiring increased cavity widths to achieve thermal properties expected by Building Regulations (courtesy NHBC)

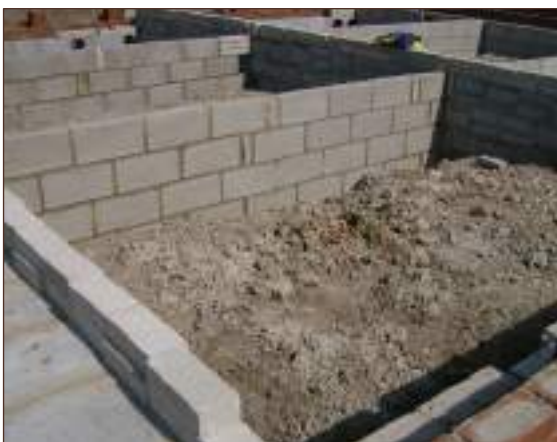
**Figure A4.89** No ventilation in internal sleeper wall (courtesy Smith Grant)
