# VERIFICATION REQUIREMENTS FOR GAS PROTECTION SYSTEMS

Technical Guidance for  
Developers,  
Landowners and  
Consultants

Yorkshire and Lincolnshire  
Pollution Advisory Group

Version 1.1 – December 2016

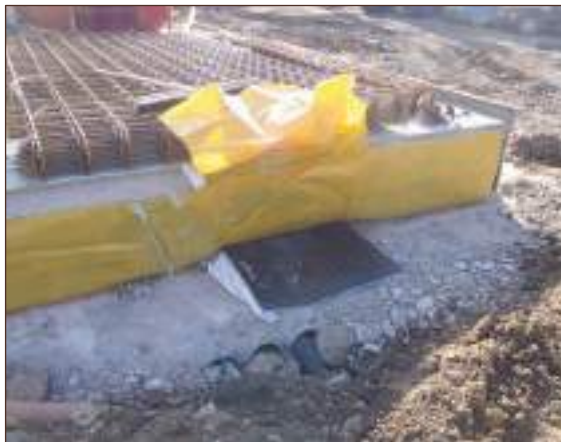
**Figure A4.7** Geovent protruding out of the frontage of the unit. Gas membrane along the sides of the slab preventing lateral gas ingress (courtesy Alderburgh Group)

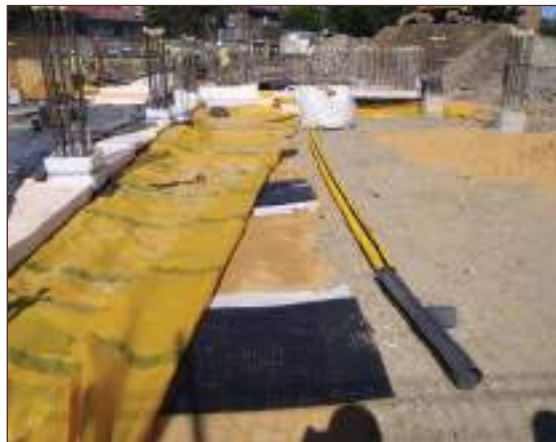
**Figure A4.8** Geovent beneath the 2000g taped gas membrane lined up with collector pipes (courtesy Alderburgh Group)

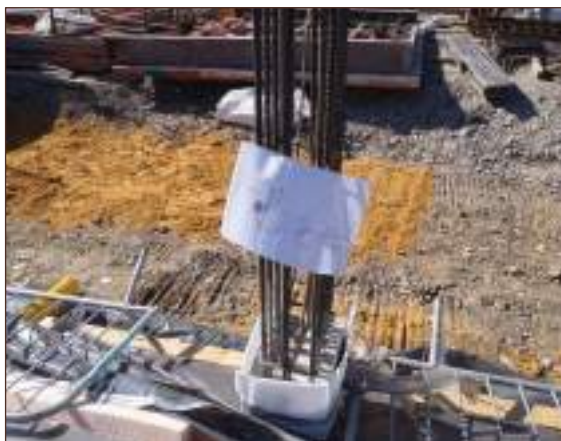
**Figure A4.9** On site schematics to aid construction workers build the gas protection system (courtesy Alderburgh Group)

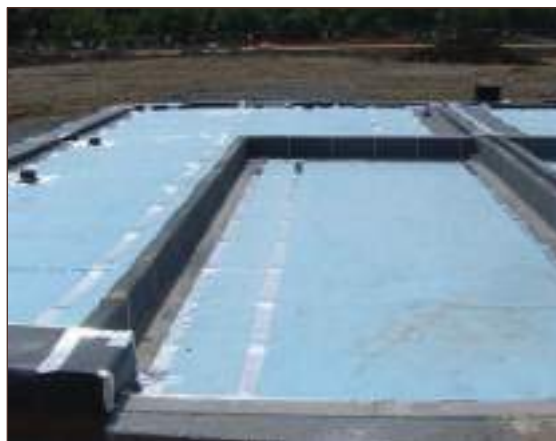
**Figure A4.10** Almost complete coverage available for inspection, minimal jointing, service entries suitable distance from walls, light traffic (courtesy Smith Grant)

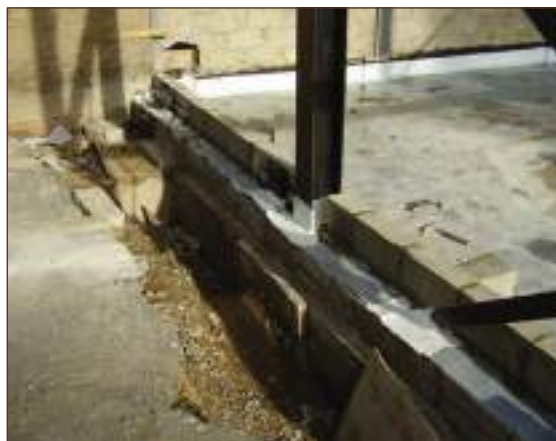
**Figure A4.12** Good edge detail across cavity (courtesy PAGEotechnical Ltd)

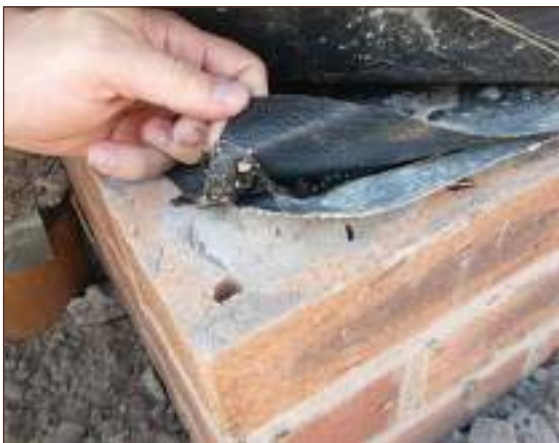
**Figure A4.13** Gas proof DPC adhered on top of gas membrane using butyl strips across cavity space (courtesy NHBC)

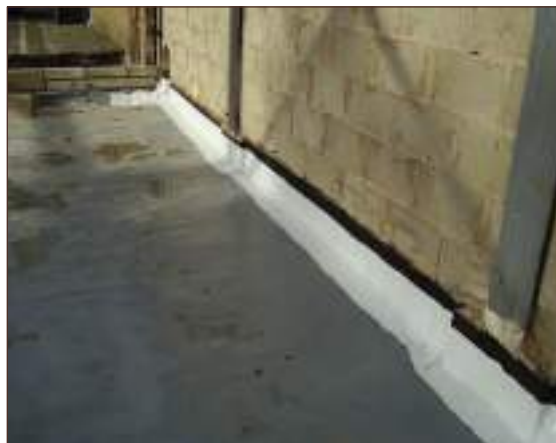
**Figure A4.14** Good perimeter seal (courtesy PAGEotechnical Ltd)

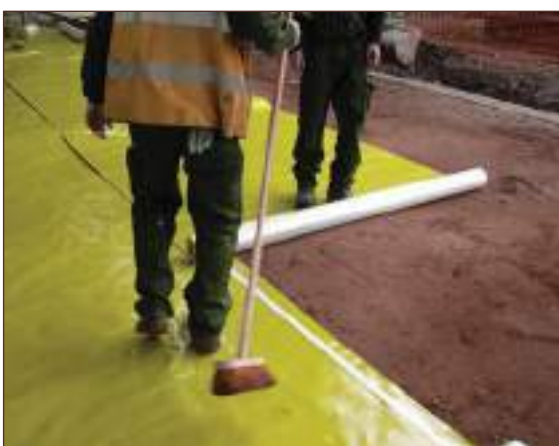
**Figure A4.15** LDPE type gas membrane overlap and double sided tape. Sand blinding to protect underside of gas membrane (courtesy A Proctor Group)

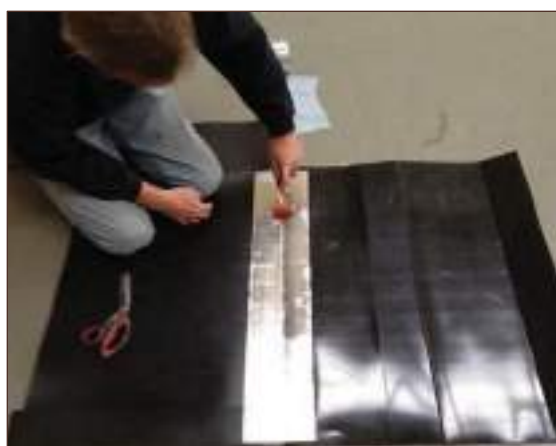
**Figure A4.16** Example HDPE type gas membrane and steam roller used to ensure self-adhesive tape is correctly installed (courtesy A Proctor Group)

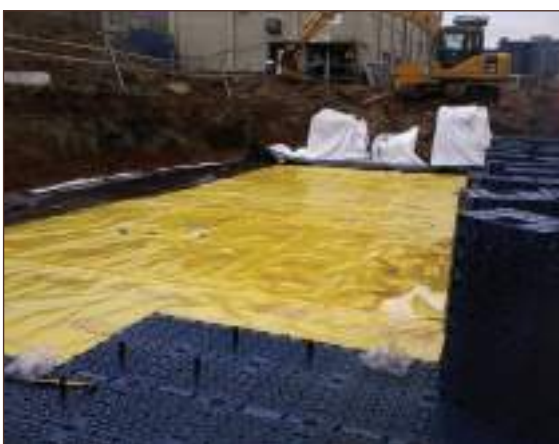
**Figure A4.17** Gas membrane installed in attenuation tank (courtesy Industrial Textiles & Plastics Ltd)

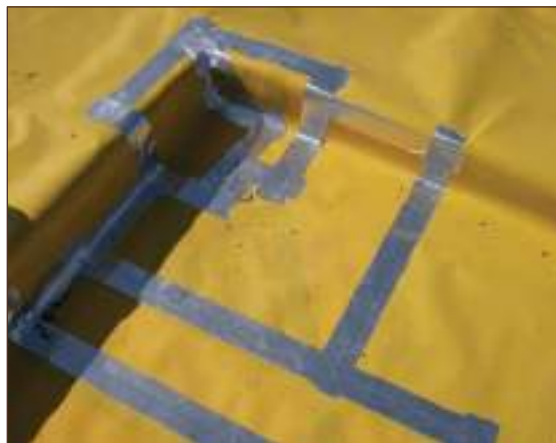
**Figure A4.20** A pre-formed corner unit would have been preferable as fewer joints would have been formed, however the installer has achieved a good level of workmanship in this corner detail (courtesy Smith Grant)

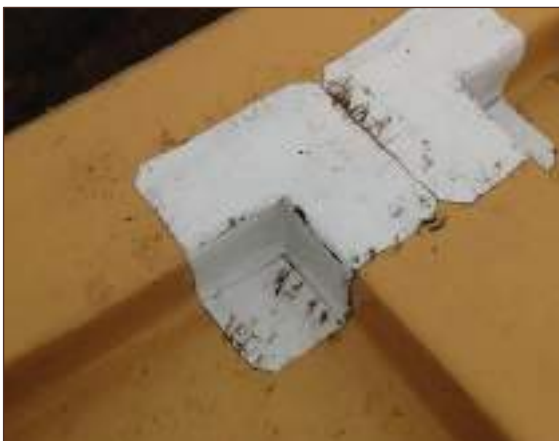
**Figure A4.21** Good prefabricated corner detail (courtesy MEC Environmental Ltd)

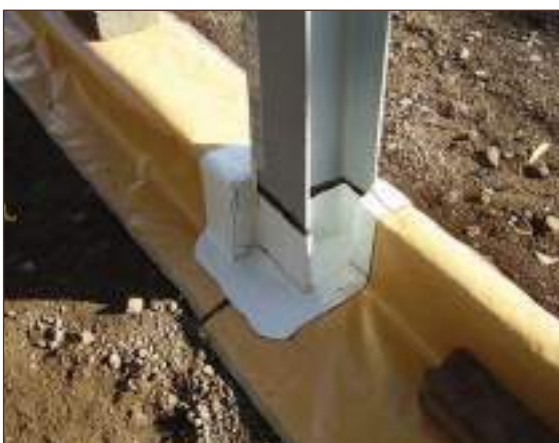
**Figure A4.23** Complex column seal (courtesy PAGEotechnical Ltd)

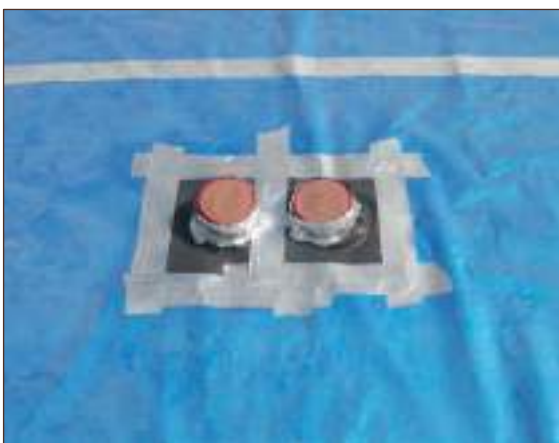
**Figure A4.27** Top hats placed around service entries secured with jubilee clip seals. Top hats secured to gas membrane with double sided butyl tape (courtesy Hydrock)

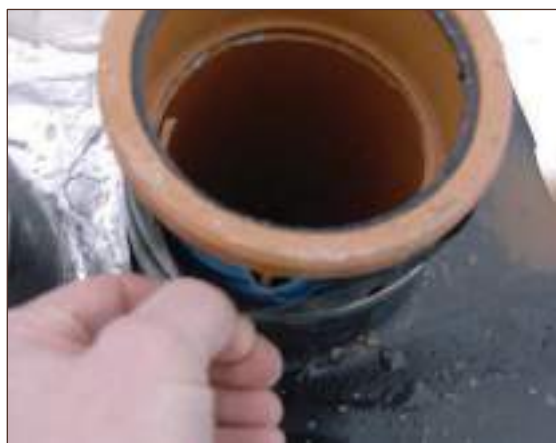
**Figure A4.28** Bead of double sided butyl tape provided between interfaces of ID top hat and OD service pipe. When compressed with jubilee clip, forms an effective seal (courtesy Smith Grant)

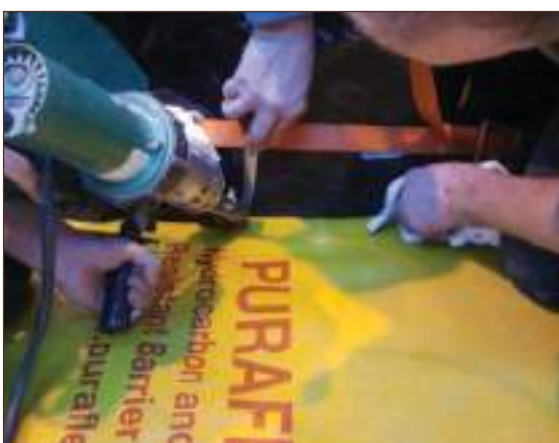
**Figure A4.29** Extrusion welding technique (courtesy Industrial Textiles & Plastics Ltd)

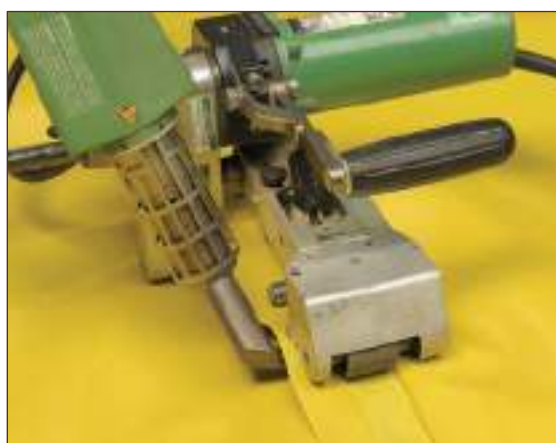
**Figure A4.30** Thermal welding technique (courtesy Industrial Textiles & Plastics Ltd)

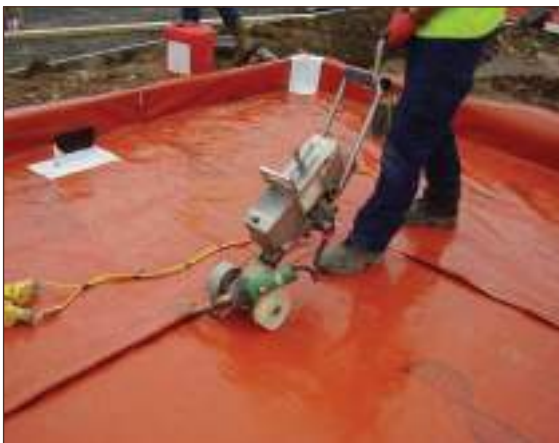
**Figure A4.31** *Extrusion welding (courtesy PAGEotechnical Ltd)*

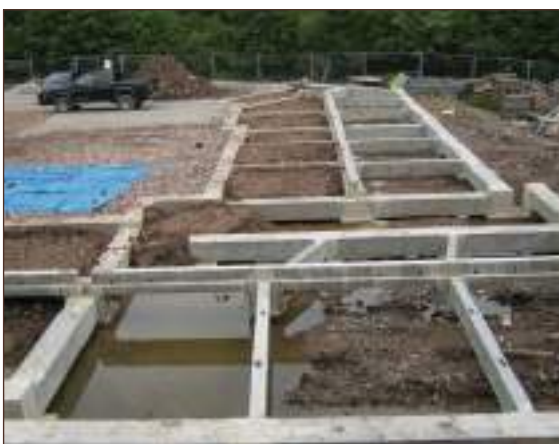
**Figure A4.33** *Good ventilation in internal sleeper walls, cast into prefabricated beams (courtesy Smith Grant)*

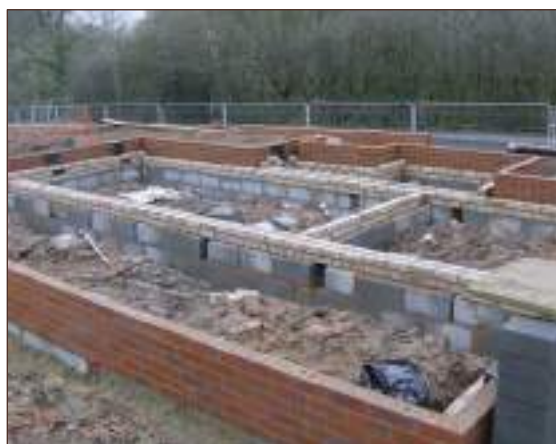
**Figure A4.34** *Open void >300mm deep, good ventilation through internal sleeper walls (courtesy Smith Grant)*

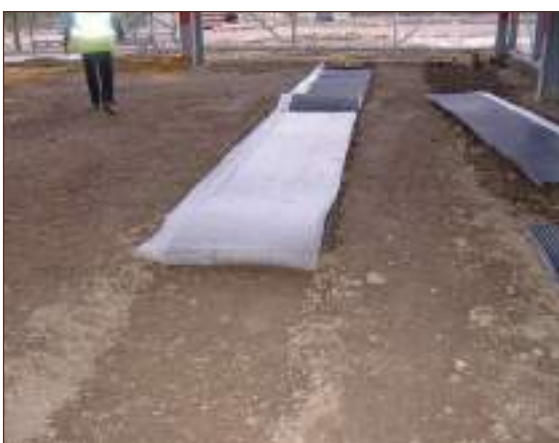
**Figure A4.35** *Good installation of passive gas venting trenches and 'egg-crate' (courtesy Card Geotechnics Limited)*

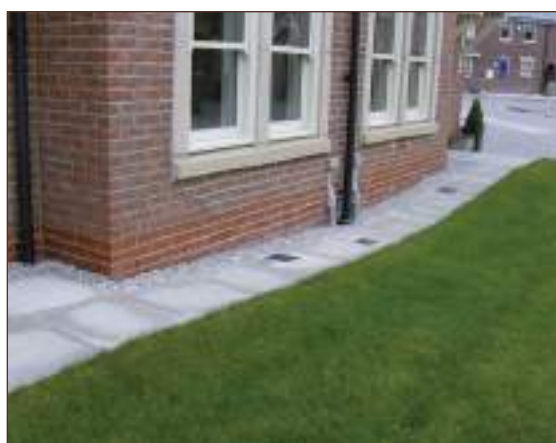
**Figure A4.36** *Raised air bricks are preferable due to the reduced potential for blockade but the vent trench specified is provided with clean single sized stone (courtesy Smith Grant)*

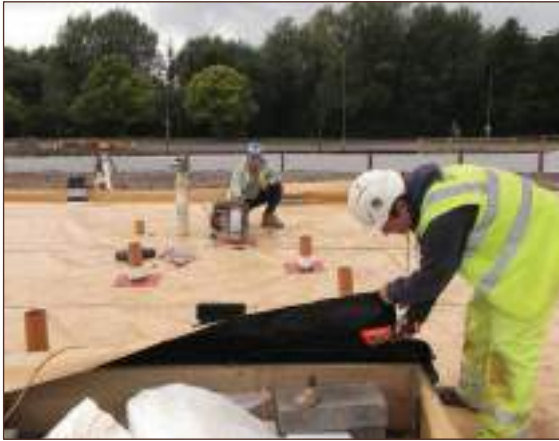
**Figure A4.37** Tracer gas testing, whereby gas or smoke is applied under pressure beneath the installed gas membrane and detectors are used to screen for leaks above (courtesy NHBC)

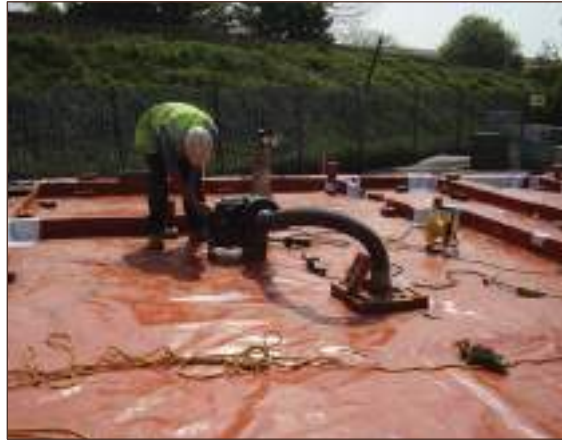
**Figure A4.38** Tracer gas testing (courtesy PAGEotechnical Ltd)

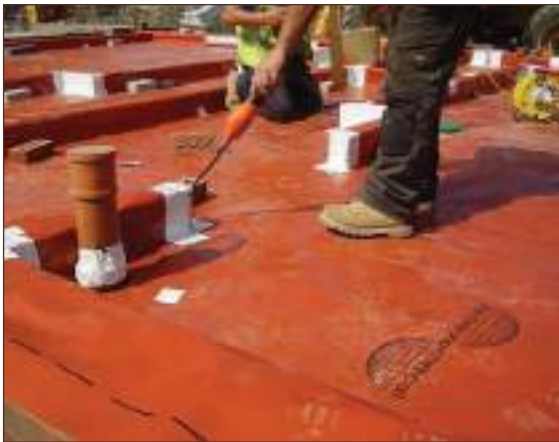
**Figure A4.39** Scanning for leaks (courtesy PAGEotechnical Ltd)

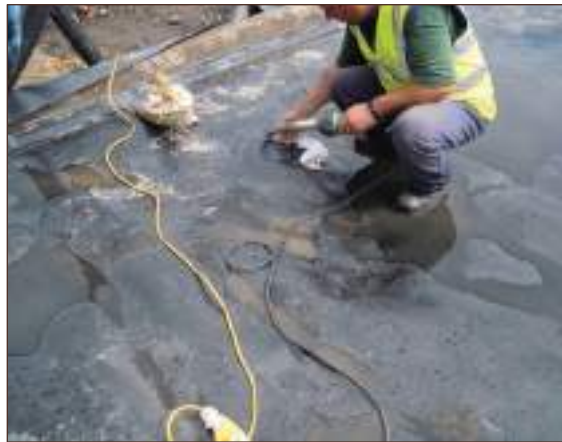
**Figure A4.40** CO<sub>2</sub> injection integrity testing (courtesy Landline Ltd)

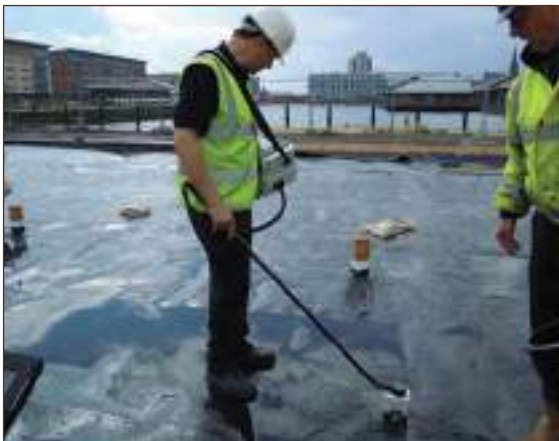
**Figure A4.41** Small sand bags are marking holes made in the gas membrane used to check whether injected CO<sub>2</sub> has worked its way beneath whole area (courtesy Landline Ltd)

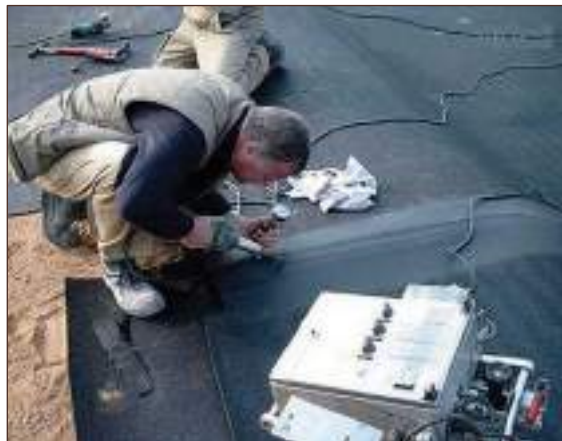
**Figure A4.42** Air pressure testing (courtesy GSE Environmental)

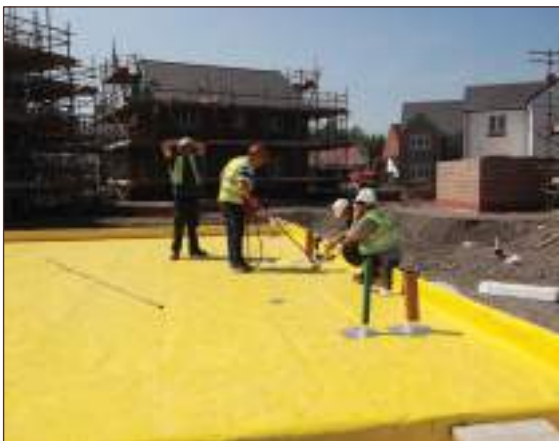
**Figure A4.43** Dielectric porosity testing for housing scheme (courtesy NHBC)

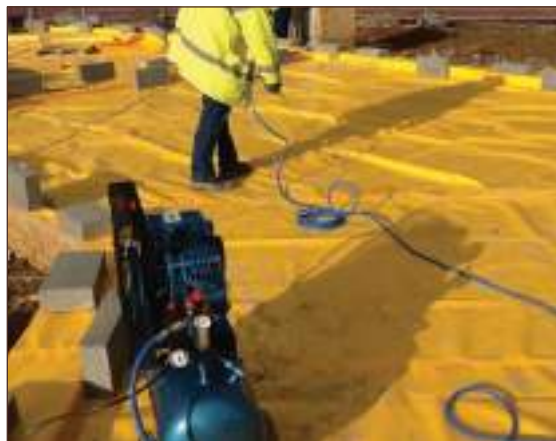
**Figure A4.44** Air lance test, used to test the quality of welded seams along gas membrane joints (courtesy MEC Environmental Ltd)

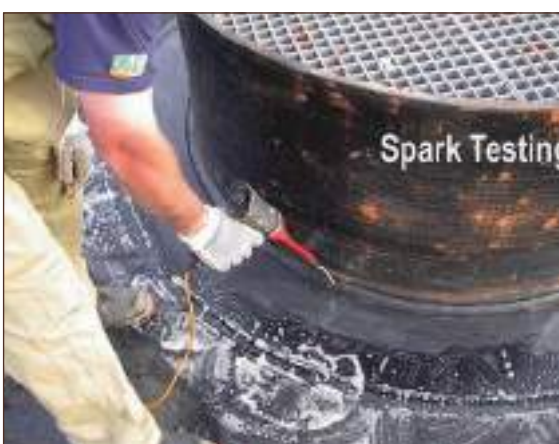
**Figure A4.45** Spark testing (courtesy GSE Environmental)

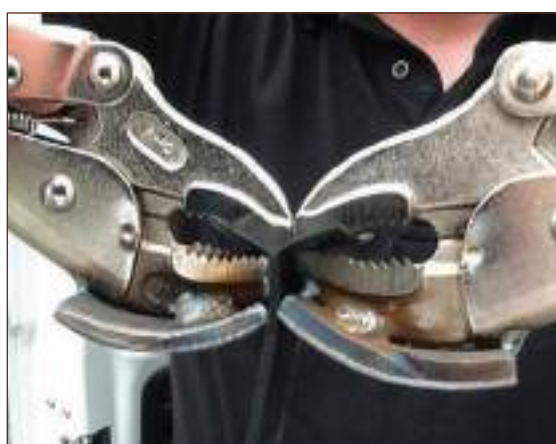
**Figure A4.46** Testing a weld with 'dog bone' grips (courtesy MEC Environmental Ltd)

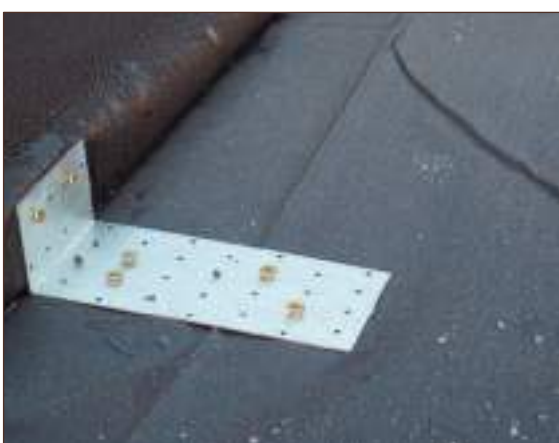
**Figure A4.47** Follow-on works purposefully penetrating gas membrane (courtesy Card Geotechnics Limited)

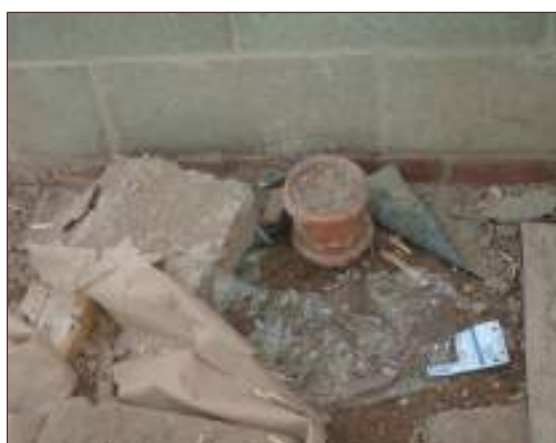
**Figure A4.48** Loose nails and over construction debris likely to be left in place beneath gas membrane – poor preparation of gas membrane prior to sealing service penetration (courtesy Card Geotechnics Limited)

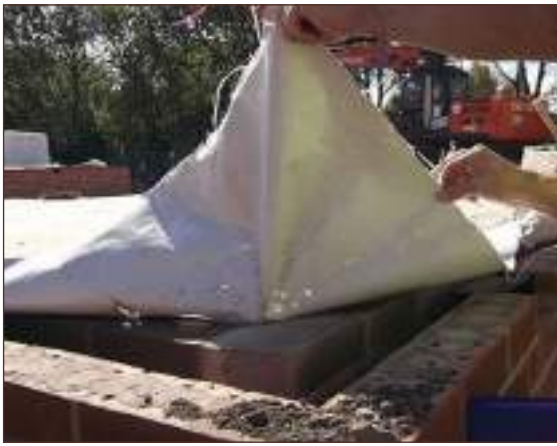
**Figure A4.49** *Lifted gas membrane at corner position. Light penetrating through confirms damage to aluminium internal core layer (courtesy NHBC)*

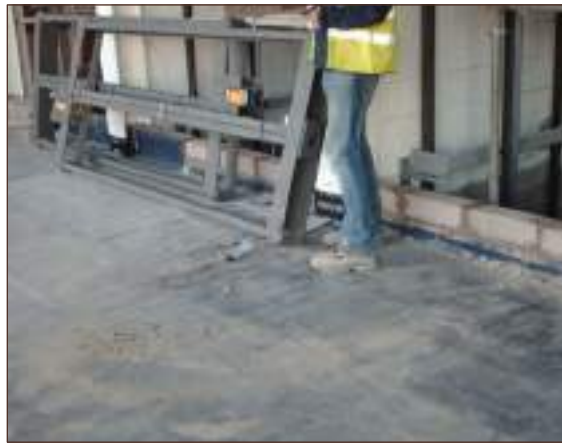
**Figure A4.50** *Large/heavy/sharp objects being moved over unprotected gas membrane (courtesy Card Geotechnics Limited)*

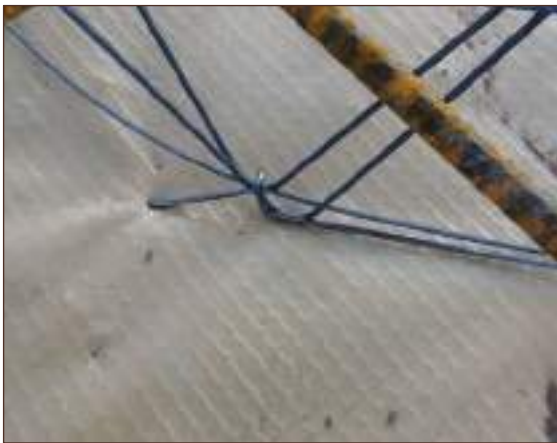
**Figure A4.51** *Gas membrane torn by reinforcement (courtesy MEC Environmental Ltd)*

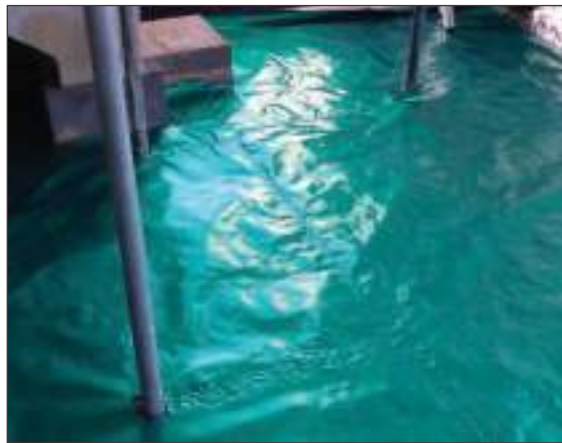
**Figure A4.52** *Gas membrane cut by scaffolders and bricklayers after installation (courtesy MEC Environmental Ltd)*

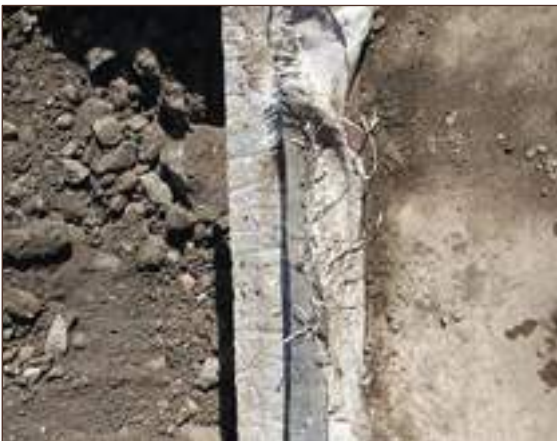
**Figure A4.53** *Gas membrane left exposed for long period of time, shows significant fraying at cavity edge (courtesy NHBC)*

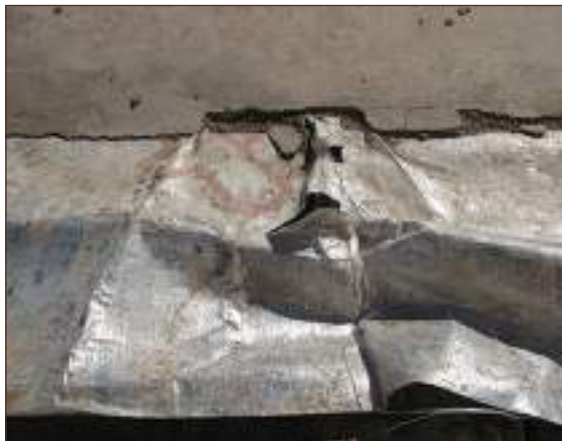
**Figure A4.54** *Gas membrane damage/tearing at edge of ground floor slab screed layer where it was left exposed to elements for period of time (courtesy NHBC)*

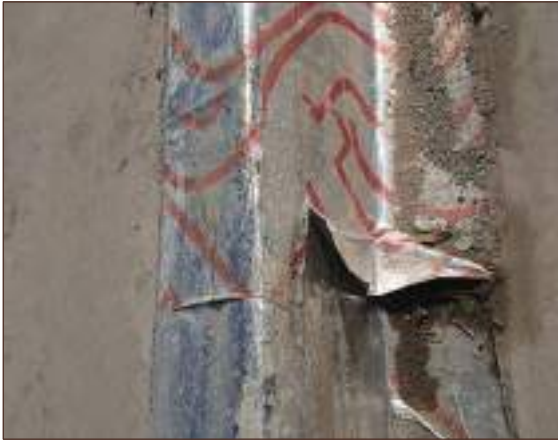
**Figure A4.55** Gas membrane at stepped junction of slab to integral garage, appears to be susceptible to tearing when screed is poured. Screed may also weigh down on gas membrane if fitted too tight (courtesy NHBC)

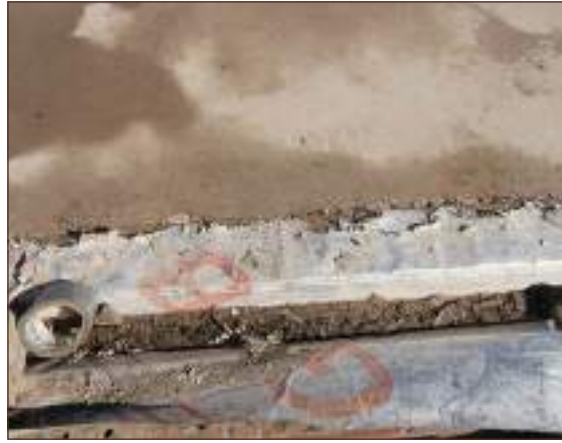
**Figure A4.56** Gas membrane at edge of concrete screed. Screed has been grinded to achieve desired levels, gas membrane shows extreme wear and damage as a result (courtesy NHBC)

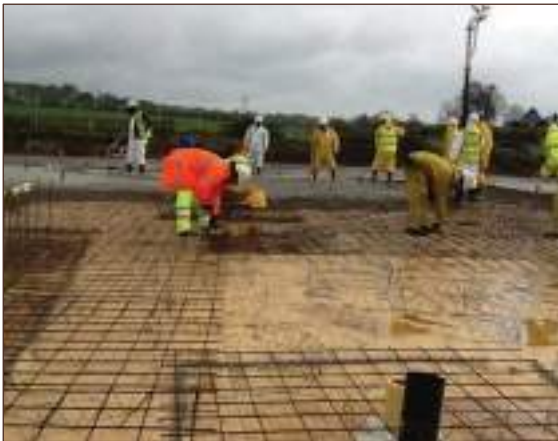
**Figure A4.57** Unprotected gas membrane damaged by heavy traffic (courtesy MEC Environmental Ltd)

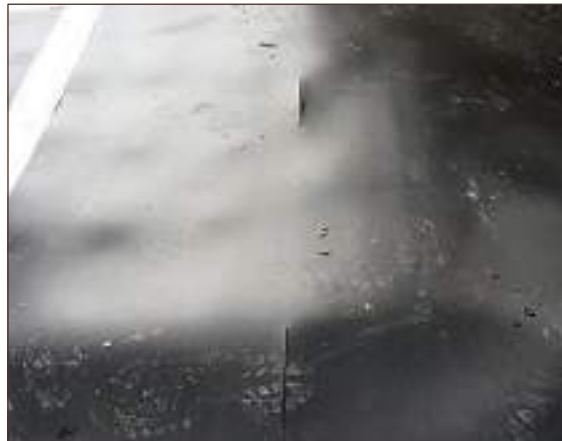
**Figure A4.58** Damage caused to gas membrane by follow-on trade who cut/shaped the dry lining board directly on the unprotected installed gas membrane (courtesy NHBC)

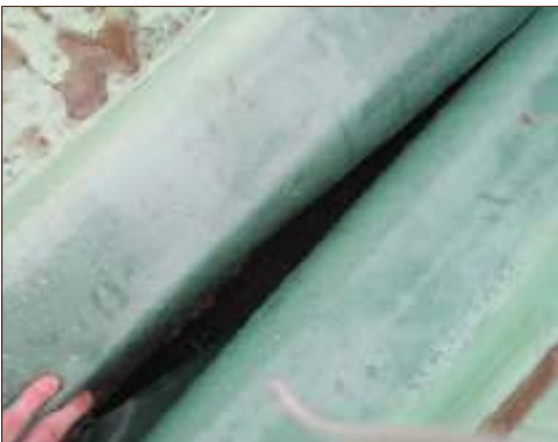
**Figure A4.59** Gas membrane slit at the bottom of a cavity tray to enable water to drain away (courtesy Smith Grant)

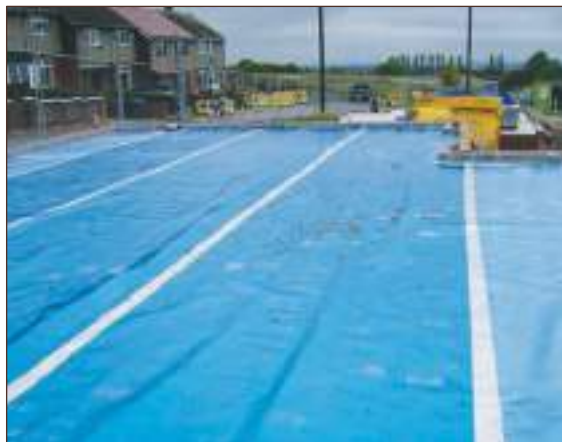
**Figure A4.60** Some stones could penetrate gas membrane if sufficient force is applied (courtesy Smith Grant)

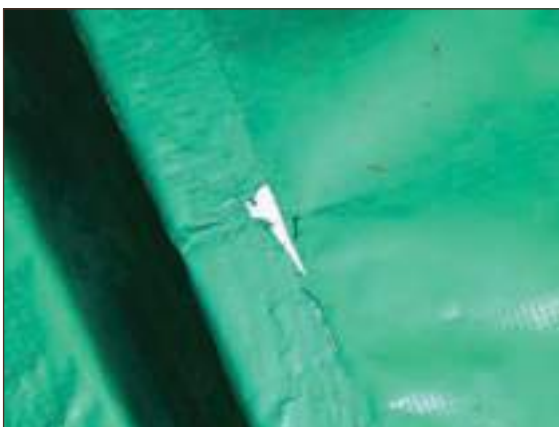
**Figure A4.61** 'Stripping' occurs on gas membranes that contain aluminium foil. The foil gets too hot under the outer layer of LDPE or PP and the top layer of the gas membrane sticks to the roller which strips it off, leaving the aluminium completely exposed (courtesy MEC Environmental Ltd)

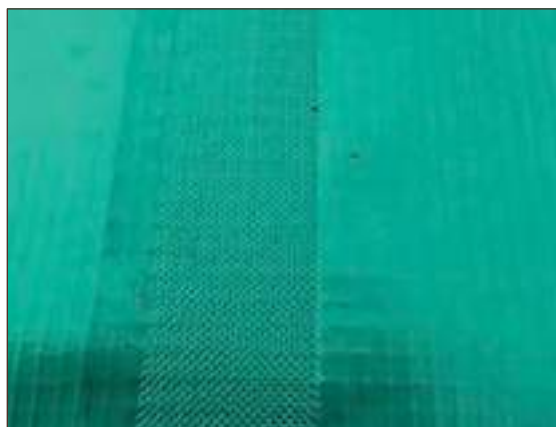
**Figure A4.62** Wedge weld on an LDPE aluminium gas membrane, where the installer used metal nip rollers. This destroyed the top layer and probably the bottom layer, leaving aluminium exposed between the weaves. This failed dielectric testing along all joints (courtesy MEC Environmental Ltd)

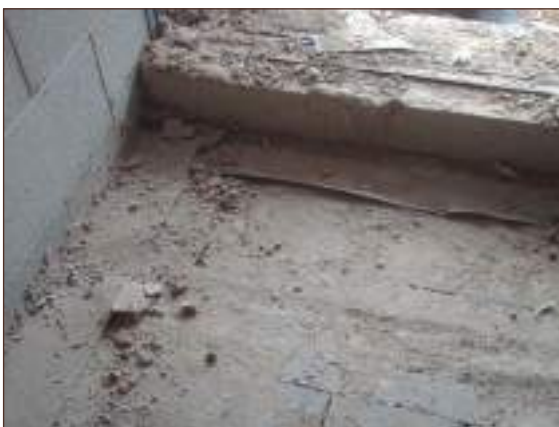
**Figure A4.63** Absence of surface preparation prior to laying of gas membrane, debris likely to pierce gas membrane (courtesy Card Geotechnics Limited)

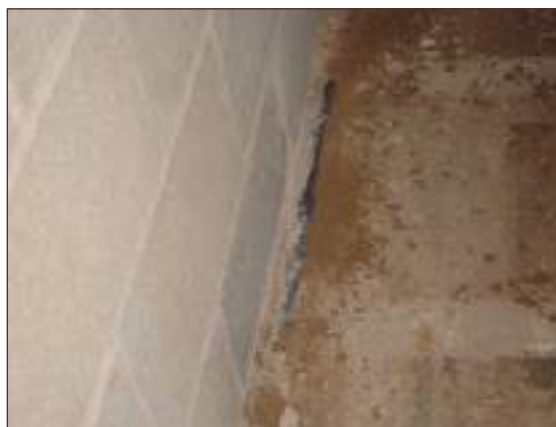
**Figure A4.64** Insufficient length of gas membrane protruding through wall to overlap with gas membrane within building (courtesy Card Geotechnics Limited)

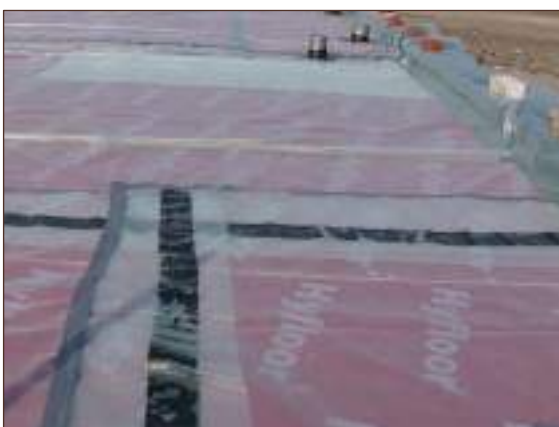
**Figure A4.65** Wrinkling of gas membrane over joint has resulted in gaps (only visible due to the use of a transparent gas membrane) and the secondary seal uses ordinary gaffer tape rather than a proprietary product (courtesy Smith Grant)

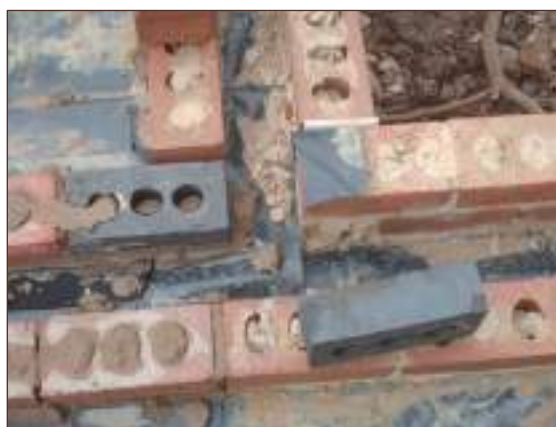
**Figure A4.66** Follow-on trades proceeded work before gas membrane joints sealed (courtesy Card Geotechnics Limited)

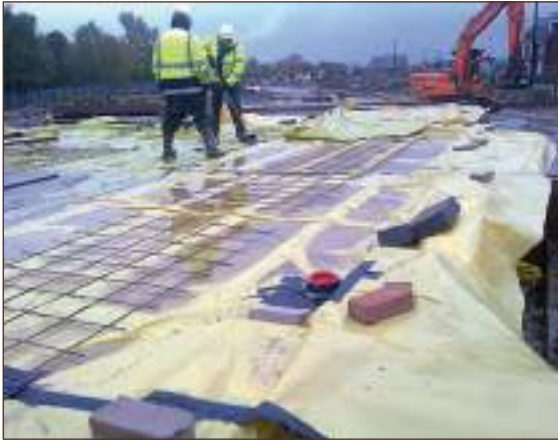
**Figure A4.67** Traffic over mesh resulted in several punctures, in addition most joints were found to be poorly constructed. Taped joints are difficult to construct in adverse weather (courtesy Smith Grant)

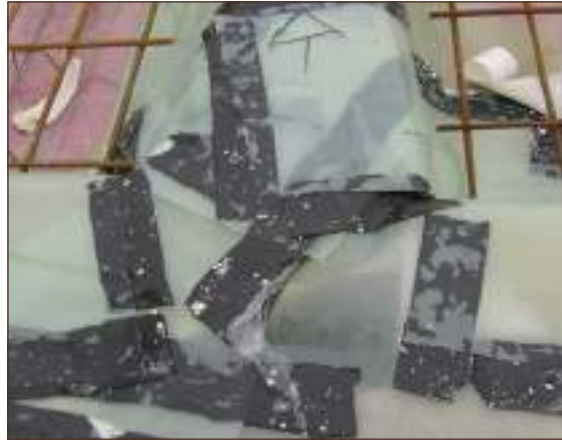
**Figure A4.68** A pre-formed corner unit would have been preferable. The installer could not produce sufficient quality despite the amount of tape applied (courtesy Smith Grant)

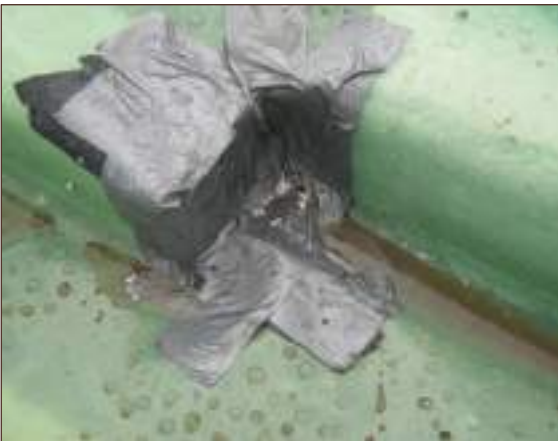
**Figure A4.69** Attempt at corner detailing using non-proprietary duct tape (courtesy Smith Grant)

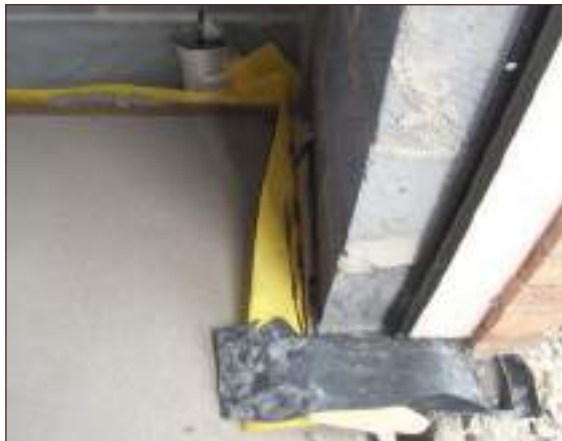
**Figure A4.70** Inadequate corner detailing. The use of preformed proprietary products would have avoided such bad practice (courtesy NHBC)

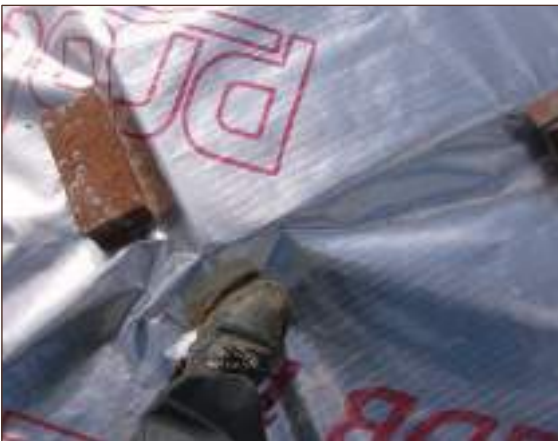
**Figure A4.71** No corner detailing leading to stress point on gas membrane (courtesy Smith Grant)

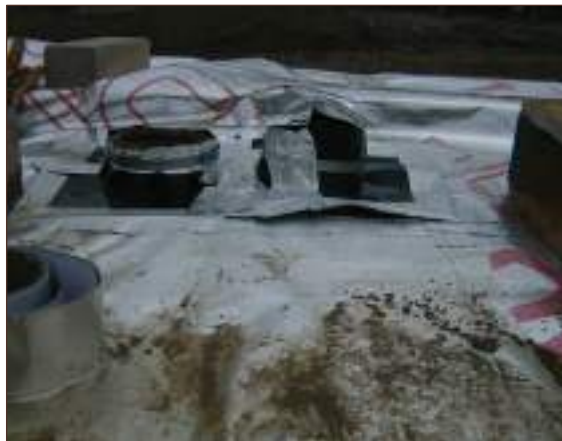
**Figure A4.72** Joint between top hat and gas membrane has lifted due to poor fit and attempt to construct in very wet conditions (courtesy Smith Grant)

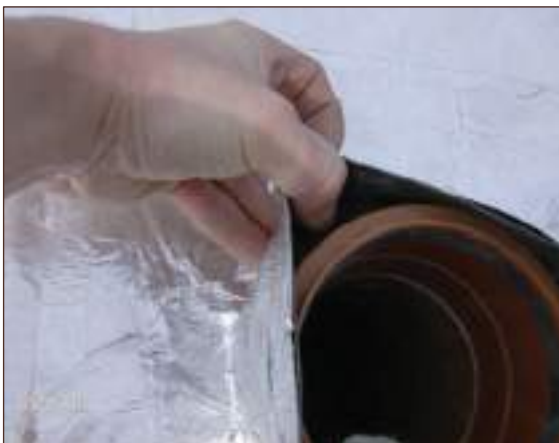
**Figure A4.73** No bead of double sided butyl tape provided between interfaces of ID top hat and OD service pipe: cannot be compressed enough to form seal (courtesy Smith Grant)

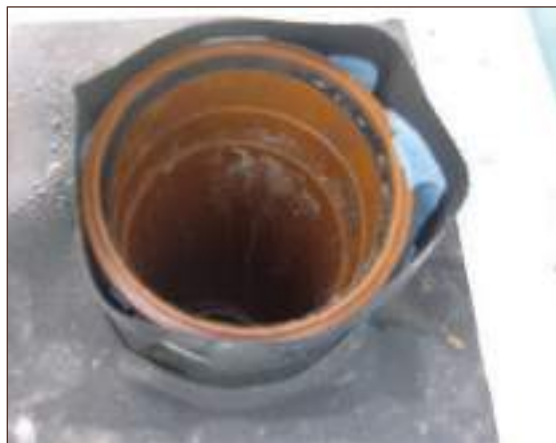
**Figure A4.74** Gap between OD of service pipe and ID of top hat too large: cannot be compressed enough to form seal, even with the application of additional tape (courtesy Smith Grant)

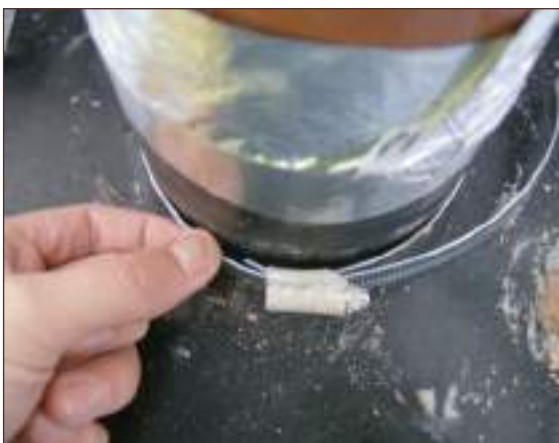
**Figure A4.75** Jubilee clip on service entry insufficiently tightened so joint is uncompressed (courtesy Smith Grant)

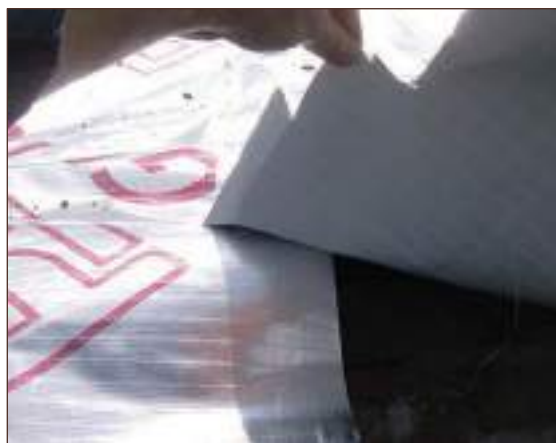
**Figure A4.76** No double sided tape used in joints (courtesy Smith Grant)

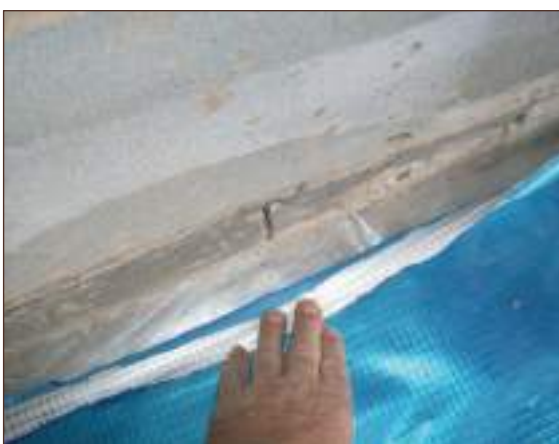
**Figure A4.77** Small lap and no single sided tape used to achieve secondary seal (courtesy Smith Grant)

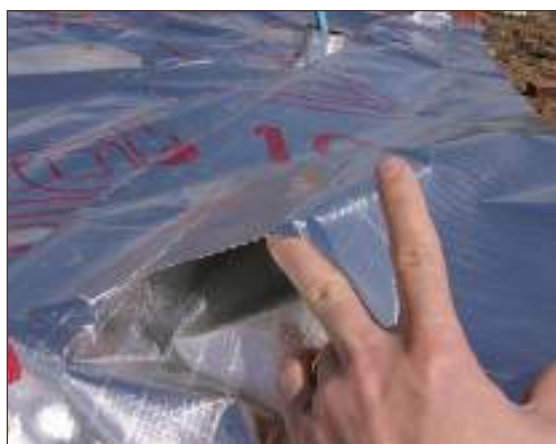
**Figure A4.78** Gap in jointing over wall cavity big enough to insert fist (courtesy Smith Grant)

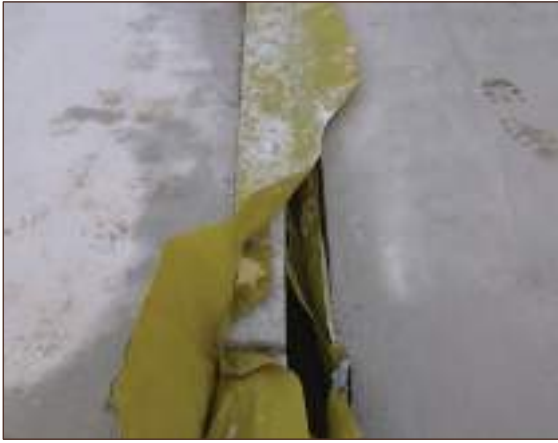
**Figure A4.79** Gas membrane not continuous over internal wall. It had been deliberately cut open for unknown purpose (courtesy Smith Grant)

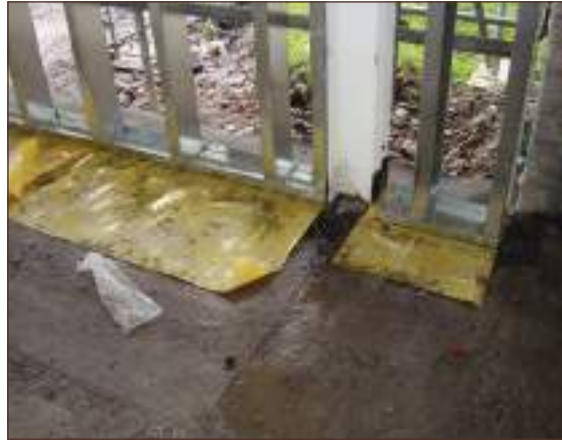
**Figure A4.80** Column left unsealed (courtesy PAGEotechnical Ltd)

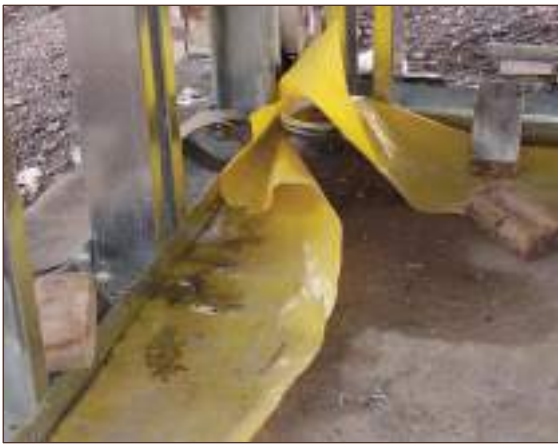
**Figure A4.81** No seal to perimeter pipe (courtesy PAGEotechnical Ltd)

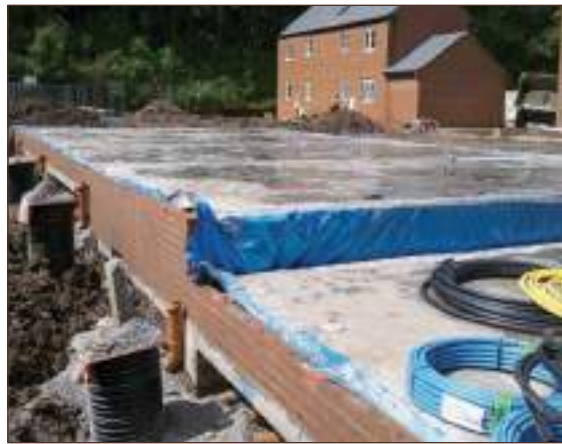
**Figure A4.82** Gas membrane used to bridge cavity wall instead of DPC, leaving it exposed to damage by follow-on trades (courtesy Smith Grant)

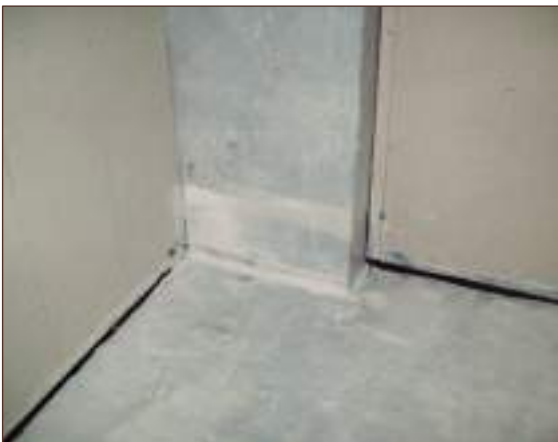
**Figure A4.83** Poor quality installation of liquid gas membrane. Liquid gas membranes come in two colours (black and white) allowing coverage of each coat to be easily assessed. Here the gas membrane has been spread too thinly and inconsistently. In addition, it appears to have been applied to a damp surface, causing blistering (courtesy Card Geotechnics Limited)

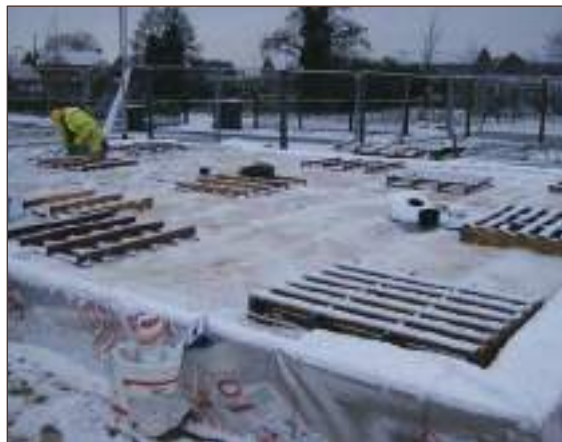
**Figure A4.84** Taped joints are difficult to construct in adverse weather. Also difficult to inspect if covered with snow (courtesy Smith Grant)

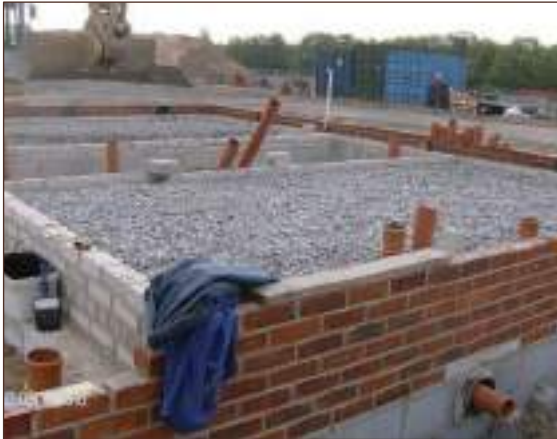
**Figure A4.85** Clean single sized stones with no fines acting as venting media, however no ventilation gaps in internal sleeper walls (courtesy Smith Grant)

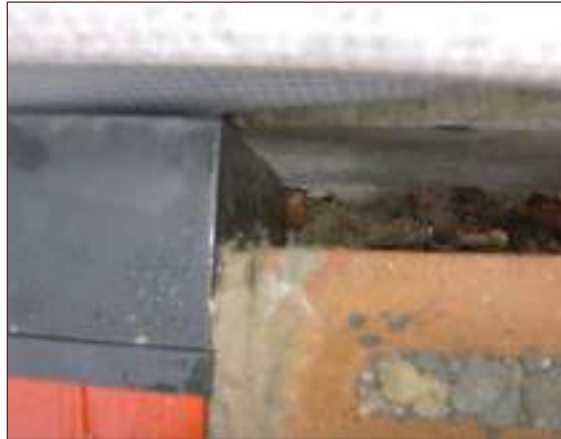
**Figure A4.86** Cavity is becoming blocked with detritus. The vent holes in the beam are no longer visible (courtesy Smith Grant)

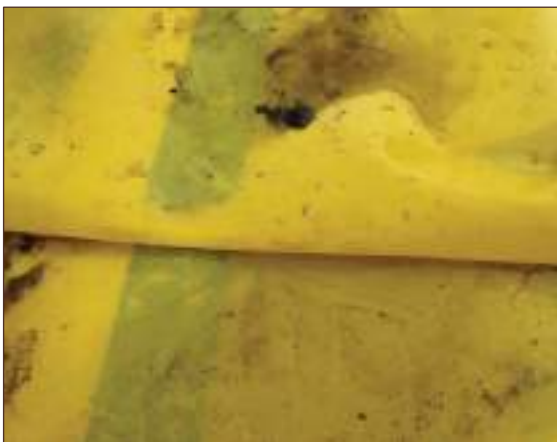
**Figure A4.87** Tape joint with crease running through and air bubbles where gas membrane not in complete contact with tape. Rollers should have been used to produce a consistent seal (courtesy MEC Environmental Ltd)

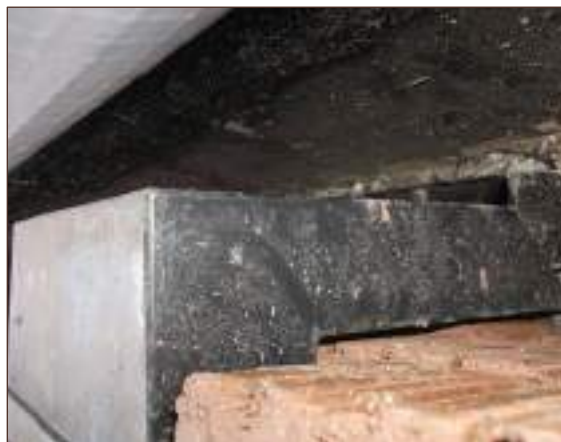
**Figure A4.88** Ventilator becoming detached to fit to external block work. This is due to builders requiring increased cavity widths to achieve thermal properties expected by Building Regulations (courtesy NHBC)

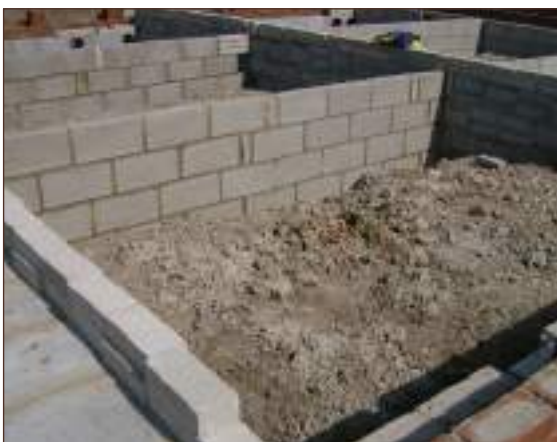
**Figure A4.89** No ventilation in internal sleeper wall (courtesy Smith Grant)
